BUILDING CONDITION ASSESSMENT

4/22/2025

120 Sunset Drive, Fredericton NB

PREPARED BY: G. Paul Dayton, P. Eng.

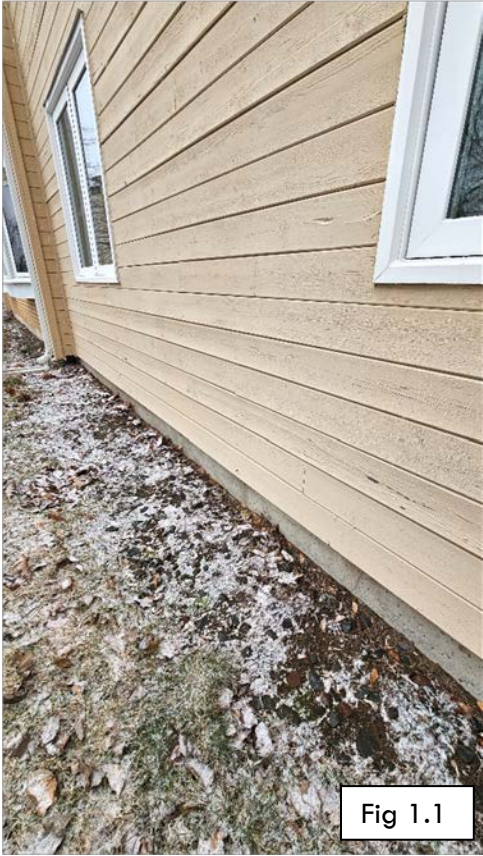
Fig 1.1

The Building Structure is constructed as a Part 9 (residential), 3 Storey, sprinklered wood frame structure and was constructed circa 1982-83. The foundations are constructed as conventional concrete frost-walls (See FIG 1.1). The foundation walls have very limited visibility (~6" Exposure) but showed no signs of differential movement. Foundation cracking was noted at consistent intervals with no visible differential movement which is common with un-reinforced concrete walls (See Fig 1.2). The roof system is a conventional engineered wood truss (See FIG1.3) clear span with 1/2" plywood sheathing with H-clips (see FIG 1.4). The attic space is properly separated above each occupancy (See FIG 1.4).

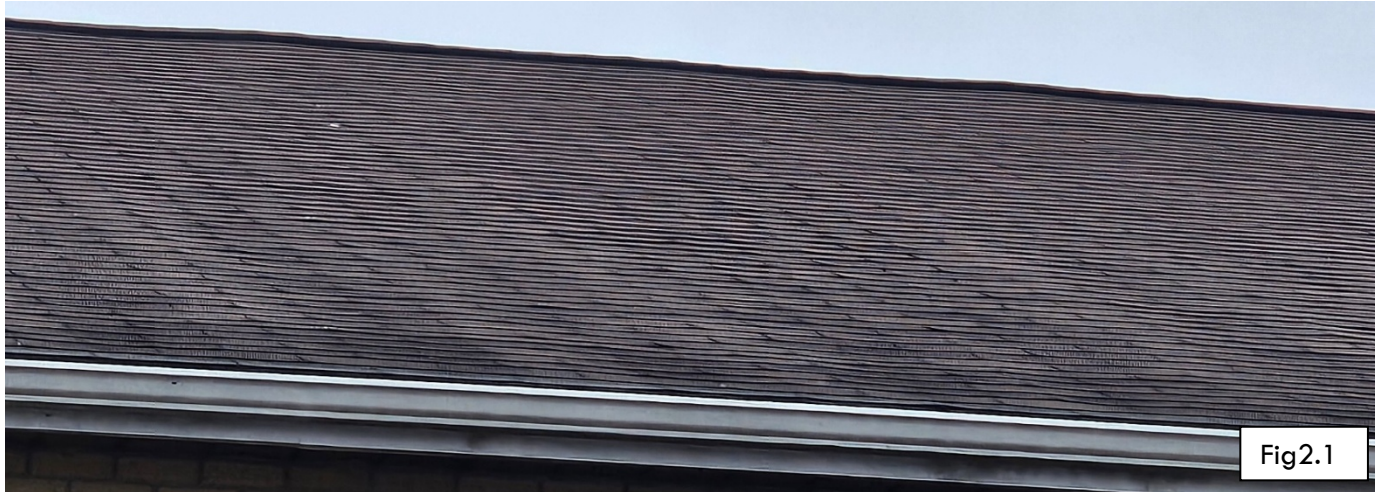
Fig2.1

Soffits appear to be cementitious and non-vented for fire protection (See Fig 2.1).. Covering of painted plywood with more durable product (ie metal flashing) is recommended before plywood degradation is beyond reasonable repair.

- Roof membrane should be included in 5 year capital reserves
- Cover painted wood fascia's with metal flashing or similar facing to protect and extend life

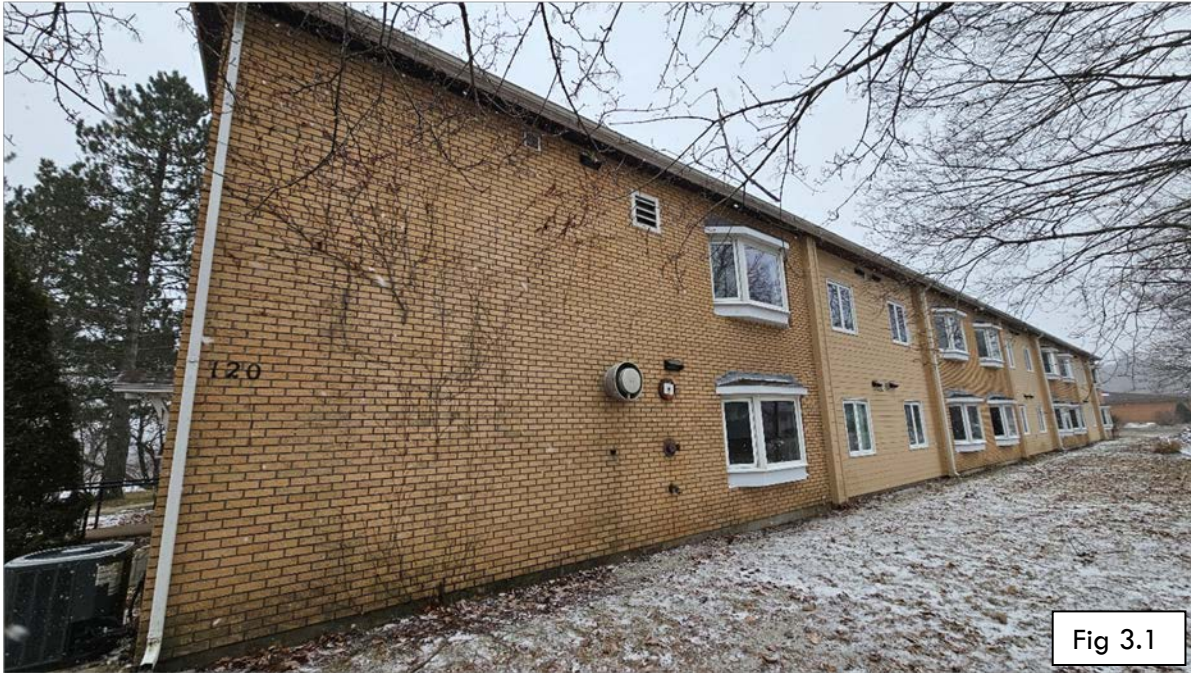
Fig 3.1

The exterior façade is comprised primarily of Brick Masonry and wood siding with large corner accents of colored brick masonry (See FIG 3.1). There is also a small amount of Hardi-plank cement siding on the North-West end of the building. Hardi-plank was recalled for some time due to the breakdown of the products binders before being reformulated into the new product line. Based on the era of installation it is possible this is from the original discontinued product line. The wood siding is showing significant evidence of absorption with areas of significant rot (See Fig 3.2-3.3). There is concern of possible water damage and rot in the exterior wall cavities due to the damage noted on the siding. Further investigation is recommended into the interior condition of the exterior walls.

- Exterior walls require further investigation for possible water damage and rot
- Exterior wood siding is due for replacement
- Cement siding should be monitored for further deterioration
- Wood soffits, fascia's, and trims should be protected with metal flashings to extend life
- Parking surfaces are due for replacement or topping on East parking area
- Sidewalks are worn and should be considered for upgrade for aesthetic purposes

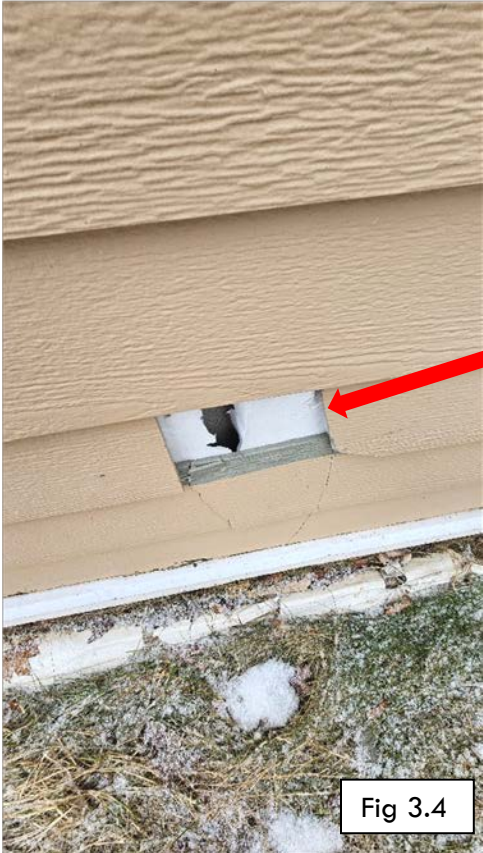
Fig 3.4

There were several holes through the siding that requires proper sealing and flashing, of note were cut holes on the North-west cement siding wall (See FIG 3.4), and various wood siding penetrations (See FIG 3.5).

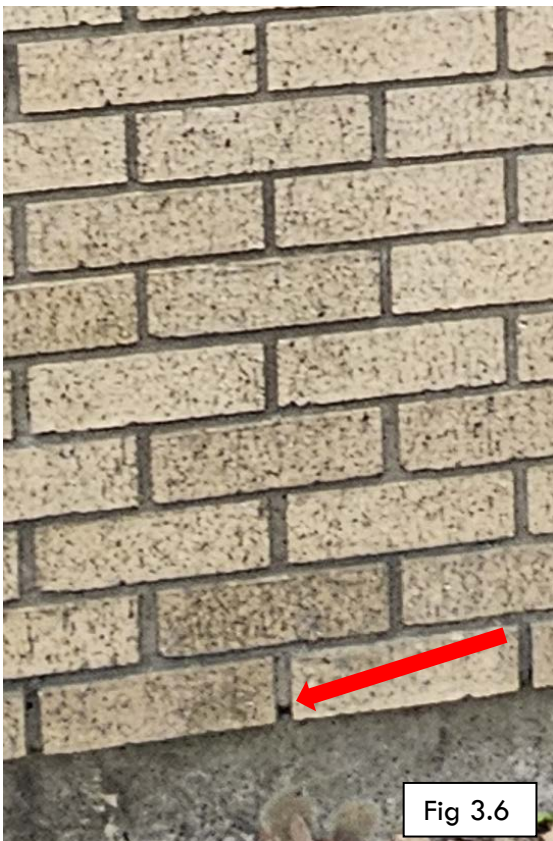
Fig 3.6

There are large brick masonry panels separated by the wood siding sections. The masonry was found to be in good repair with proper weeping (See Fig 3.6).

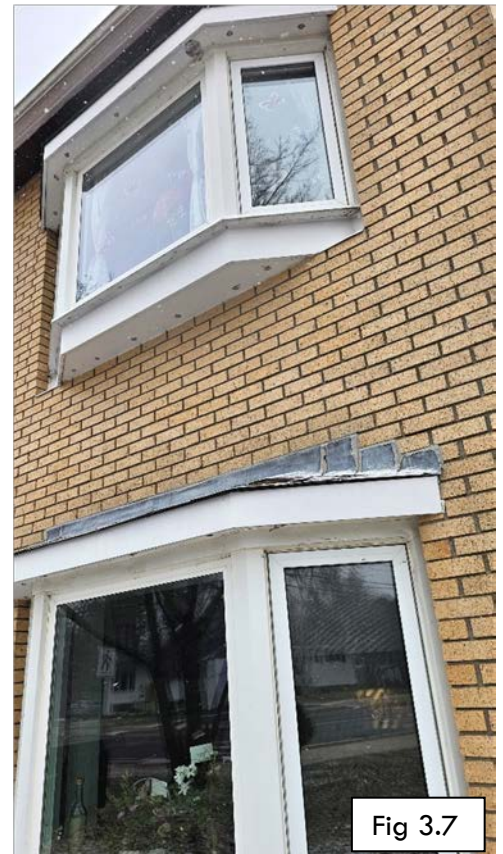
Fig 3.7

Soffits, fasciae, and trims are painted wood and plywood. The upper soffits appeared to be cement board while window bump-outs were plywood soffits and wood trims (See FIG 3.7). It is recommended that exposed wood surfaces be protected with metal flashings to extend life as there are visible signs of deterioration.

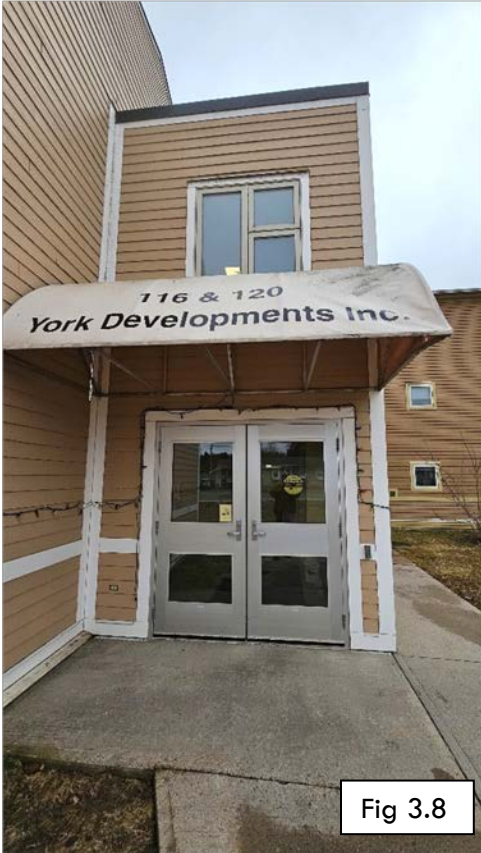
Fig 3.8

Exterior entrances are commercial aluminum and were found to be operating as intended. (See FIG 3.8-3.9).

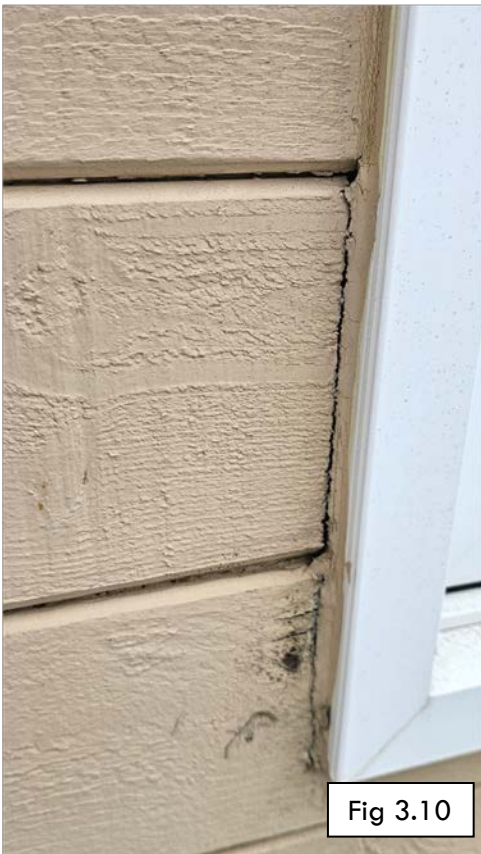
Fig 3.10

Windows are residential style Vinyl slider windows (See FIG 3.7-3.9) and were found to be in fair condition. Sealants around windows have failed in many areas (See FIG 3.10) and should be resealed immediately.

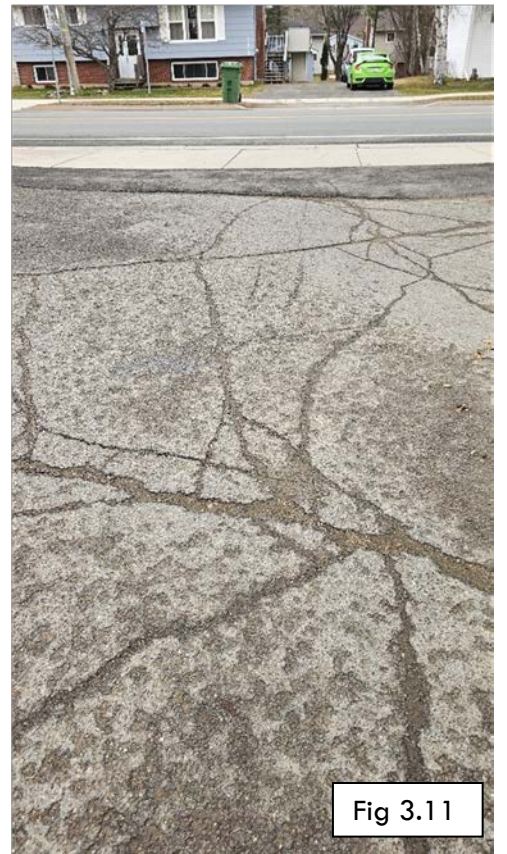
Fig 3.11

Parking surfaces are constructed of asphalt and were found in fair condition on the North-western parking area but the eastern lot was badly cracked and due for resurfacing (See FIG 3.11). The concrete sidewalks were badly weathered but still sound with no noted abrupt grade changes or tripping hazards. The sidewalks are recommended for replacement for aesthetic purposes, but they remain functional.

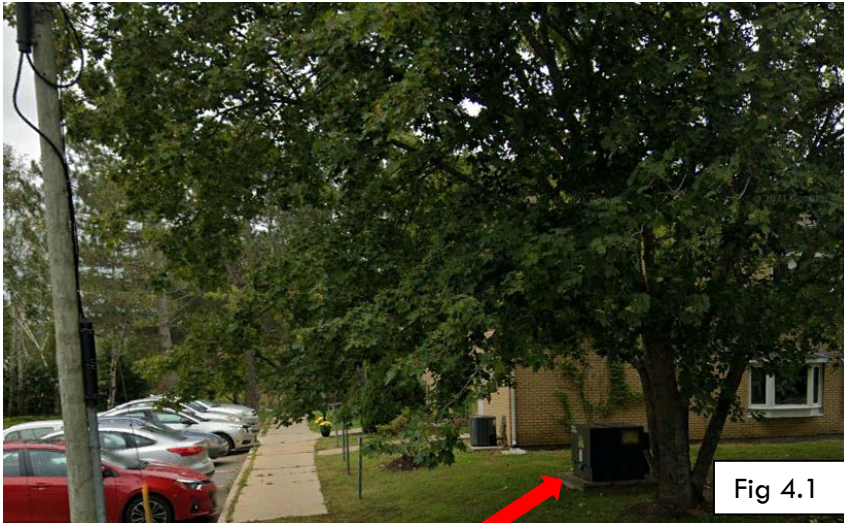
Fig 4.1

The building electrical system is supplied from a pad mount transformer on the North-East side of the building between Sunset Drive and the building (See Fig 4.1). The main service is a 120/208V 600 Amp 3Ø 4W service (See FIG 4.2 & 4.4). The building contains 25 meters (See FIG 4.2) which serve the individual units and 1 for the common areas. The main entrance is located on the North-East side of the facility in an electrical room serviceable only from the interior of the first level space.

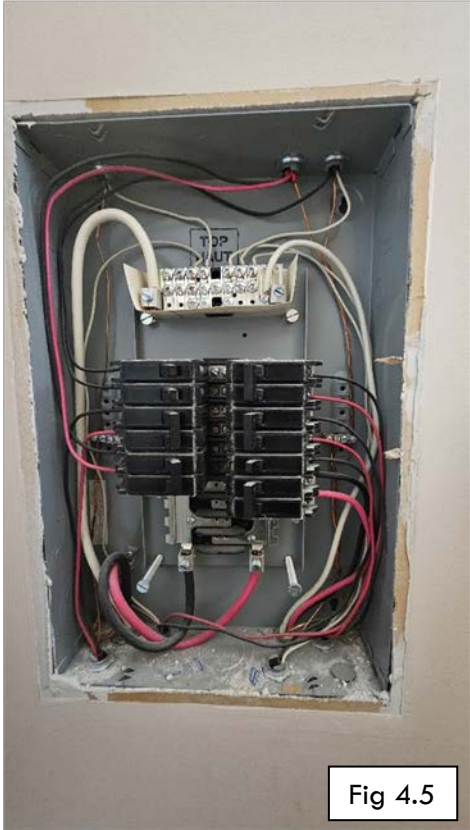
Fig 4.5

Each tenancy is serviced through a sub-panel fed from the electrical room to the entry area of each unit (See FIG 4.5).

The house service panels and sub-panels were randomly inspected and verified for proper wiring (See FIG 4.5 & 4.7) and no non-conformances were identified.

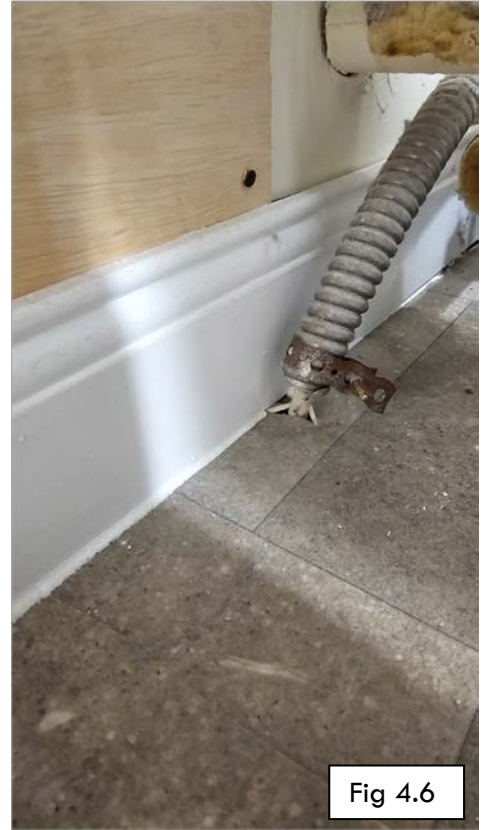
Fig 4.6

The wiring is modern properly rated material where visible and appears to be well managed throughout with labels, protected and concealed wire, and secured junctions. There was an exception noted in the laundry room where a BX cable was used to protect a feeder from beneath the floor which is not properly installed in a junction box and where unprotected wires are visible (See FIG 4.6)

- BX wire in laundry requires replacement with conforming connections and supply.
- Upgrade worn receptacles

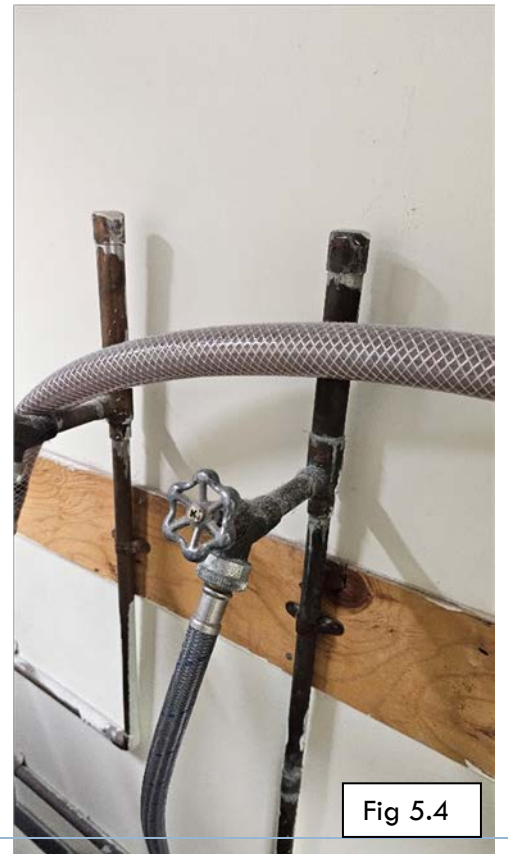
Fig 5.4

The scope of this investigation was limited to visual observation only. Domestic water service is supplied through copper piping where visible (See Fig 5.4). Waste-water piping was identified as Cast Iron below grade with a mix of copper, cast, and ABS (See Fig 5.5, 5.6). Pipe insulation was noted on much of the exposed hot and cold supply lines (See Fig 5.7). The waste system venting is copper piping (See Fig 5.4).

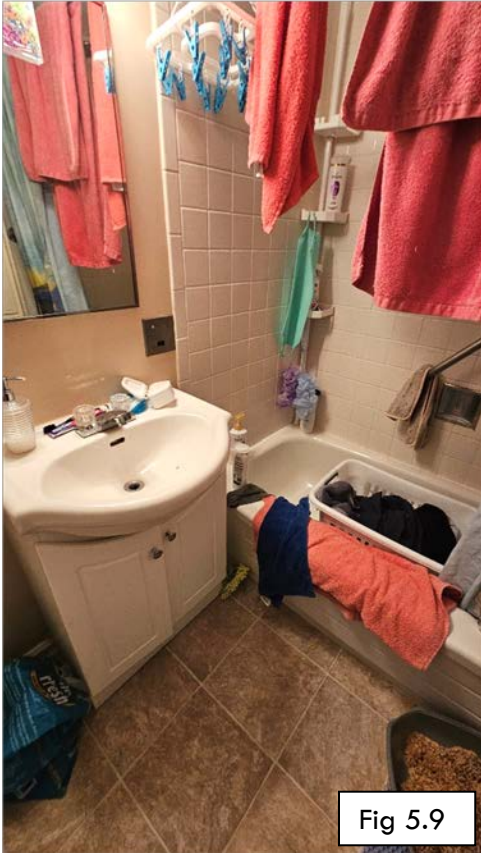
Fig 5.9

Plumbing fixtures appear to be original equipment (See Fig 5.8, 5.9) and are in fair condition.

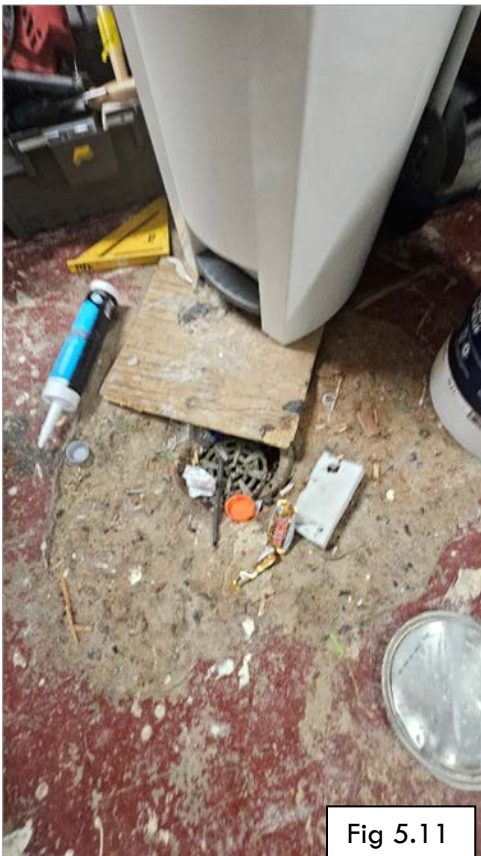
Fig 5.11

There was a floor drain identified in the service/water room which appears to be damaged and clogged with debris with a detached drain plate (See FIG 5.11). This requires cleaning and scope to ensure debris does not lead to clogged drains.

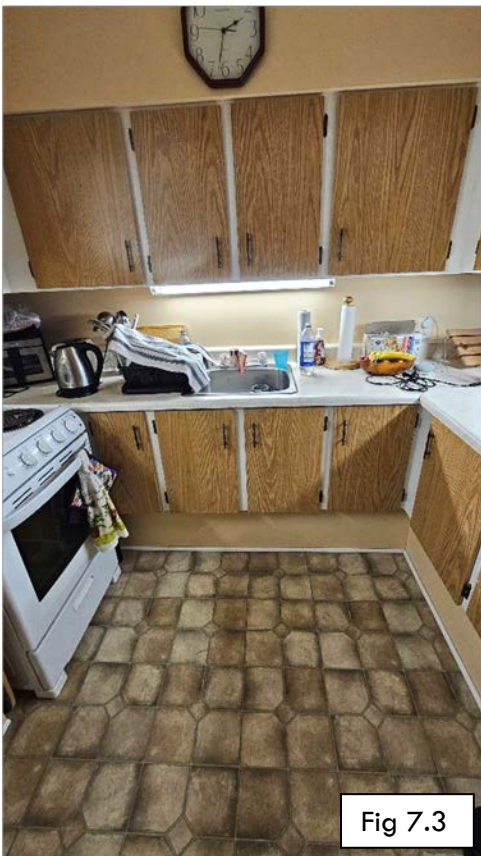
Fig 7.3

Flooring – Units were randomly inspected; finishes were found to be a mixture of newer laminates (See FIG 7.1 & 7.2) and older sheet vinyl flooring (See FIG 7.3). Sheet vinyl areas are very dated and recommended for replacement. Common areas were found to be primarily VCT in corridors with newer carpet at lobby/entry (See FIG 7.4 & 7.5). VCT remains functional with a few areas of cracking where floor substrate is uneven (See FIG 7.5)

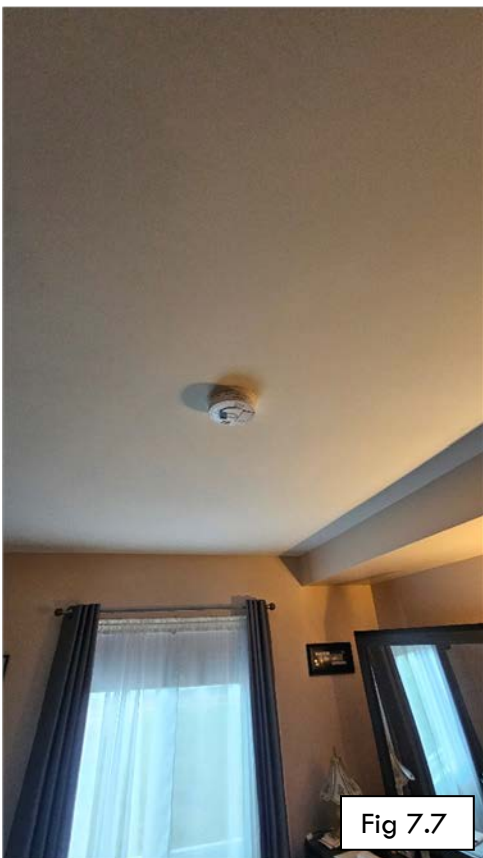
Fig 7.7

Ceilings - Ceilings are painted gyprock (See FIG 7.7) and were found in good repair with no concern noted.

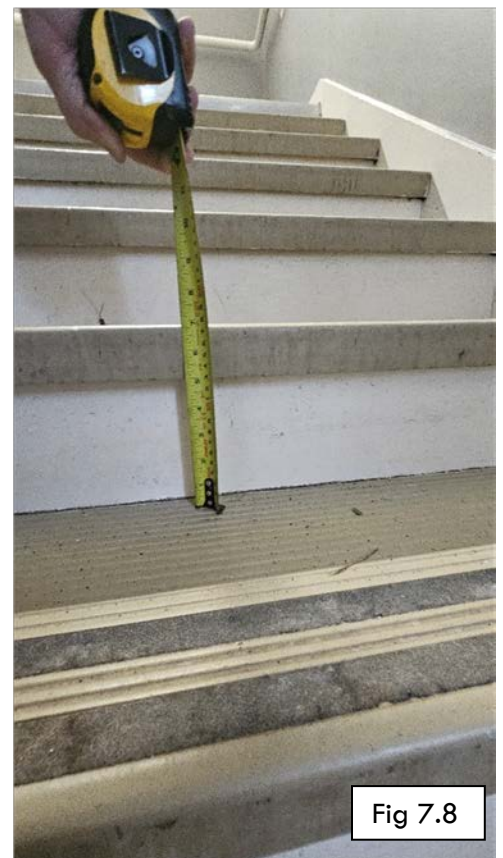
Fig 7.8

Stairs – Stairs are located on each end of the facility for exiting. The stairs conform to present day code requirements for rise (7") but the run is non-conforming at 10 3/8" when 11" is required (See FIG 7.8, 7.9). Stairways are required to maintain a minimum headroom clearance of 2.08 m. Landing bulkheads have restricted headroom which is non-conforming 1.95 m (See FIG 7.10). Stair railings were found to be conforming.

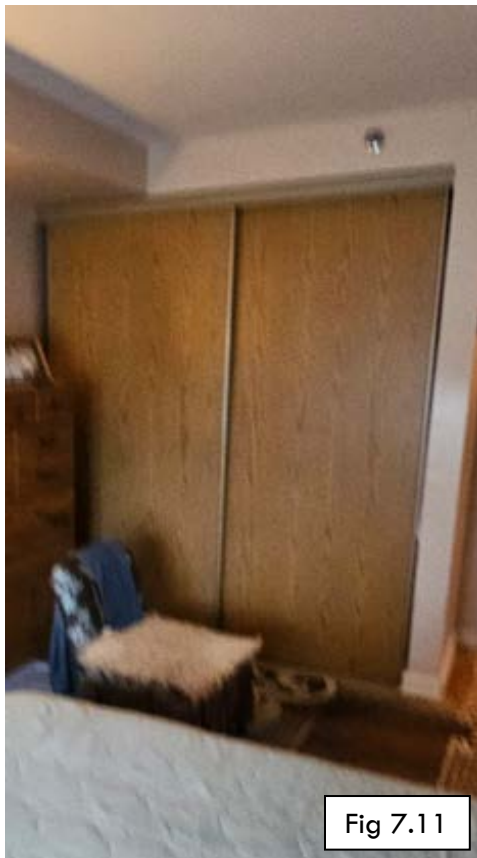
Fig 7.11

Doors – Unit interior doors are wood veneer (See FIG 7.11). The main exterior entrances is a double aluminum commercial door (See exterior commentary). The inner vestibule and corridor doors are pressed steel (See FIG 7.12-7.13). Entrances are in conformance with the present use exiting requirements. Door hardware was found to be functional and in good condition. Unit entry doors do not meet current fire rating requirements as they are not UL Certified (See FIG 7.14 and Life Safety commentary).

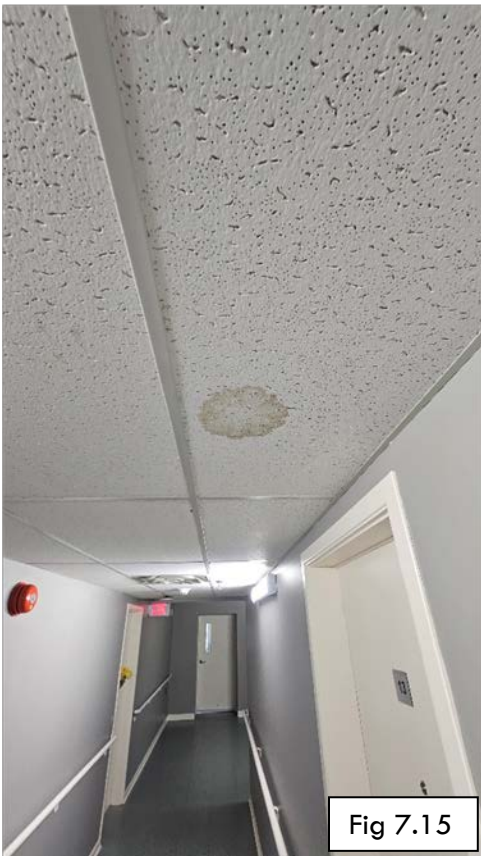
Fig 7.15

Corridor walls were found in good condition and properly rated. Corridor ceilings are T-bar and on the top level there was water damage noted (See FIG 7.15). Closer investigation revealed that the ceilings remain unfinished above T-bar with no strapping and only Vapor barrier carrying the fiberglass attic insulation. There was evidence of leaking which could be a roof leak or condensation that has caused the vapor barrier to drop (See FIG 7.16) causing ponding of water leading to the noted damages.

- Repair corridor flooring where humped and cracked on ground floor corridor
- Add support to underside of attic trusses over corridor and repair insulation.

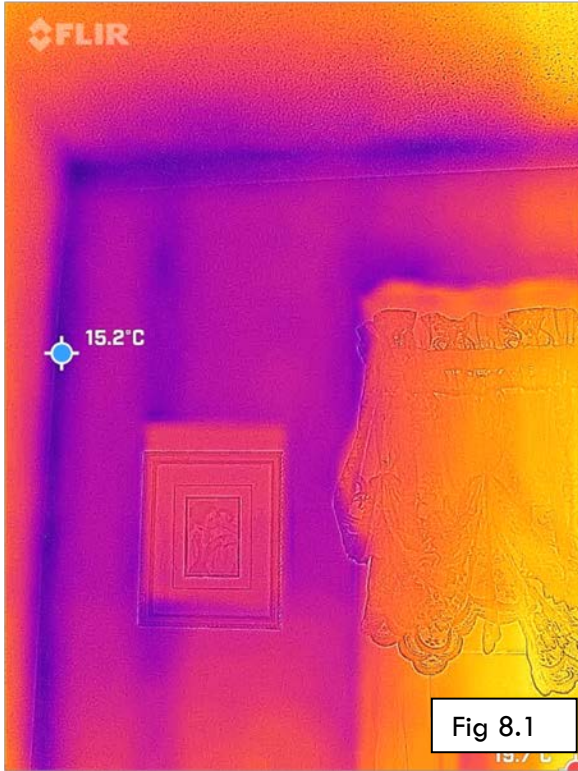
A critical component for a healthy environment is insulation and vapor barrier components. The wall assembly is inspected using moisture sensors and an IR Camera. Inspection of exterior walls revealed many cold zones with missing or damaged insulation and very poorly insulated assemblies (See Example FIG 8.1).

- R-values are non-conforming to present NBCC 2015 building code. R-Value Improvement is recommended
- Fresh air HRV system is recommended in each unit (See mechanical commentary)
- Investigate exterior walls beneath window for signs of rot or water infiltration

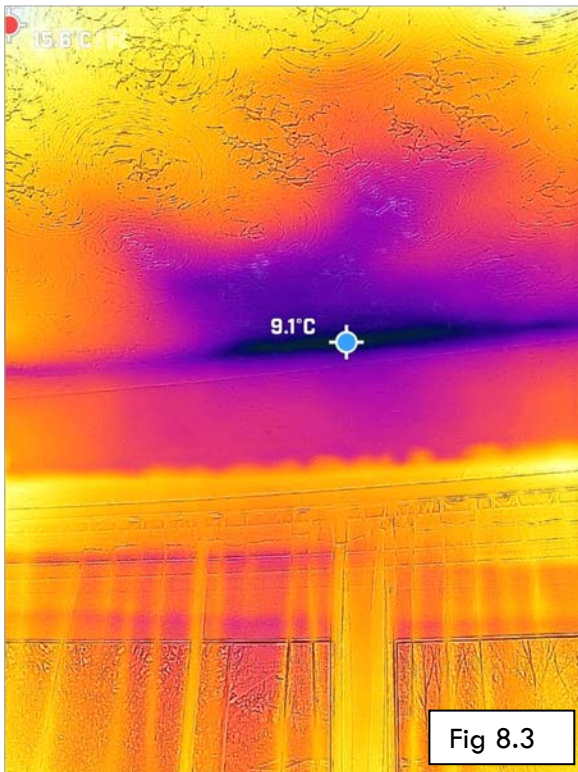
Attic insulation R-values are also non-conforming with <R40 values and many areas of wet/missing insulation were noted through the IR scans (See FIG 8.3)

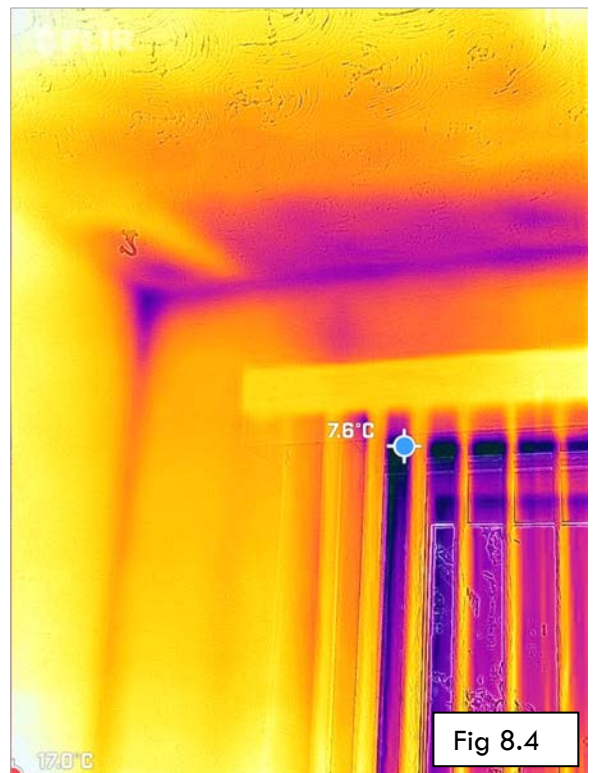
Windows show signs of cold infiltration around perimeters and trims. Air movement could also be felt in these zones (See FIG 8.4). Windows are expected to be “chinked” (stuffed with FG Batt insulation) based on age of construction which allows infiltration and air movement. Exterior sealants are also failing which can increase air transmission. Low expansion PU foam insulation is recommended around windows. Given the age of windows and building construction, a closer invasive investigation of a random selection of wall assemblies around and beneath windows is recommended to ensure no structural rot is present.

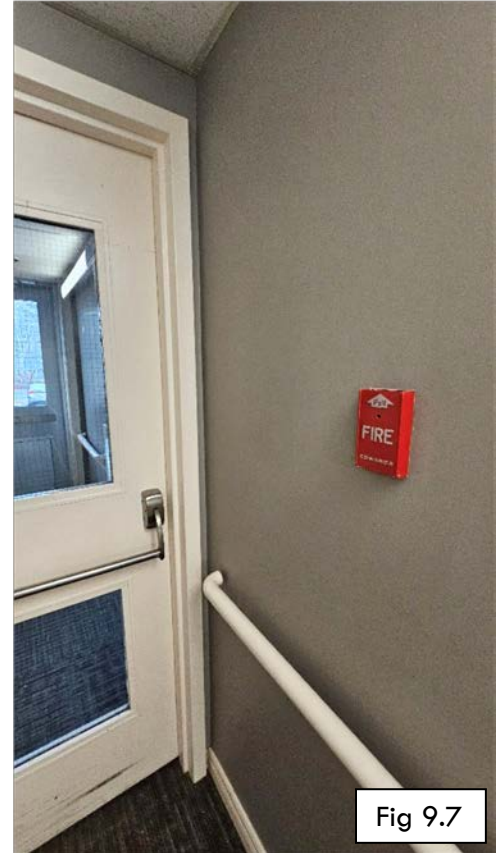
Fig 9.7

As this facility contains a fire protection system, pull stations and alarm bells in common areas are required. These systems were found to be compliant with current standards (See FIG 9.7-9.9).
