BUILDING CONDITION ASSESSMENT

3/14/2025

91 Sunset Drive, Fredericton NB

PREPARED BY: G. Paul Dayton, P. Eng.

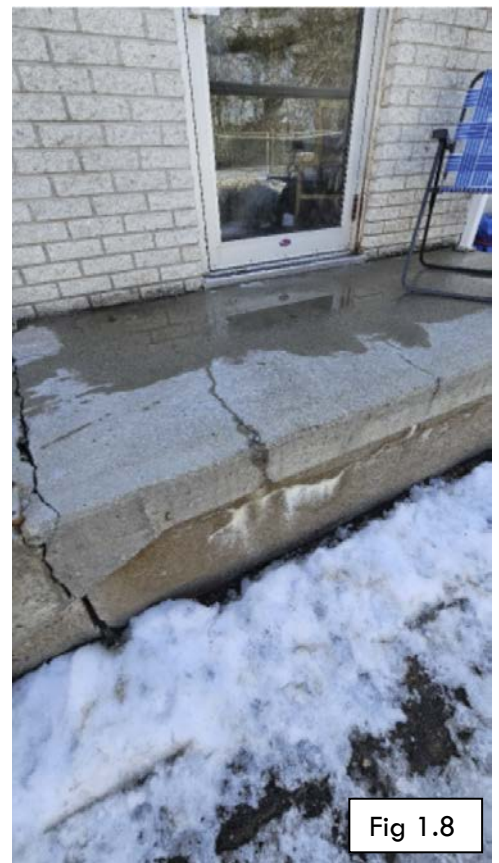
Fig 1.8

The rear sidewalk and entry landing is badly fractured with significant separation (See FIG 1.8). Complete replacement is recommended.

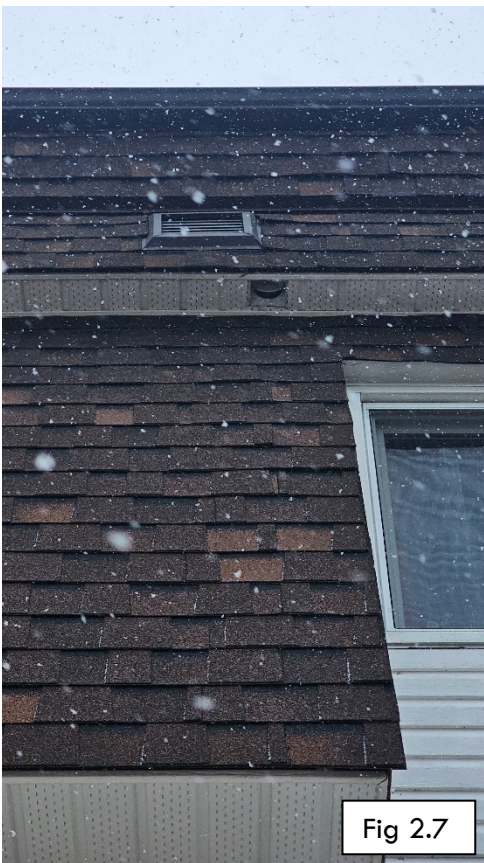
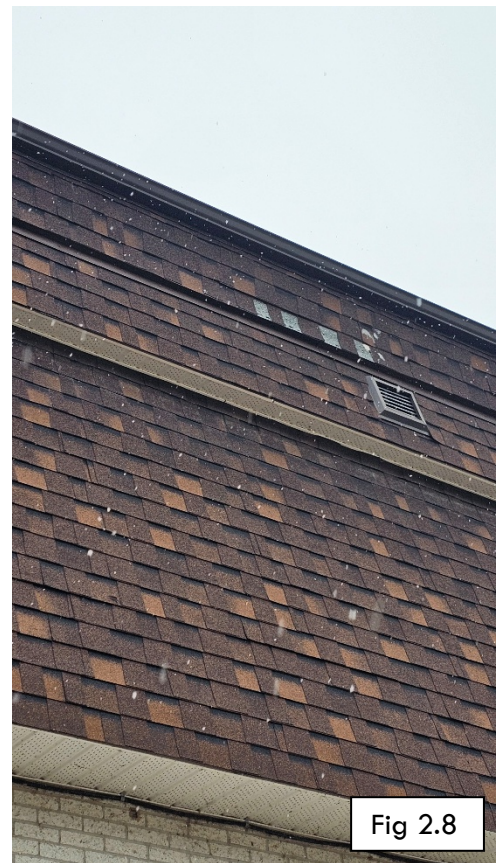
The facing of the Mansard roof is due for replacement with many broken and missing tabs with very visible curling signaling breakdown of the asphalt membrane (See FIG 2.7 – 2.8). The roof membrane has a 25 year manufacturers projected life span when installed and maintained in accordance with the manufacturers recommendations. The recently replaced portion of the roof should be outside the projected capital reserve period. The remaining portions of the roof are in need of replacement and should be scheduled for replacement this season. The leaking portion of the roof should be addressed immediately to prevent further degradation of the roof sheathing and framing.

- Mansard roof facing shingles due for replacement
- Rear portion of shingle roof needs replacement
- Roof leak in vicinity of AHU curb needs immediate repair
- Cover painted plywood Mansard fascia’s with metal to protect and extend life

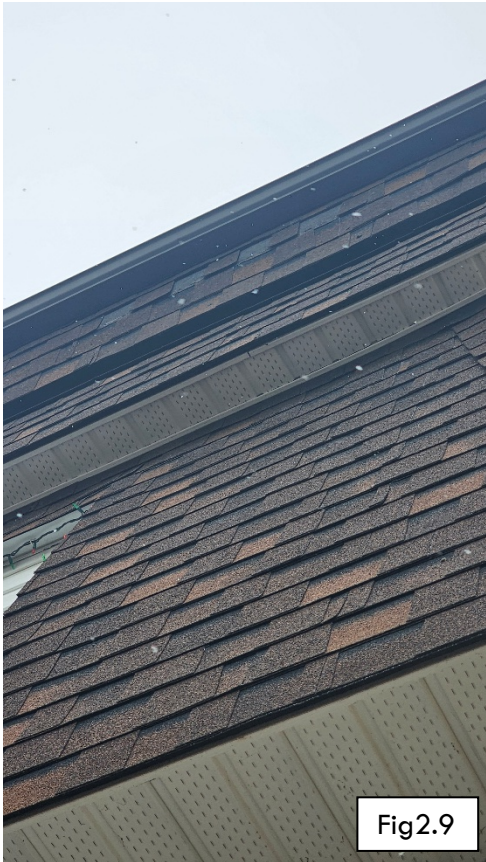
Fig2.9

The roof venting is present (See FIG 2.9), however with the double roof assembly the venting may be somewhat compromised. Due to the enclosed lower roof assembly, proper verification of the venting was not possible.

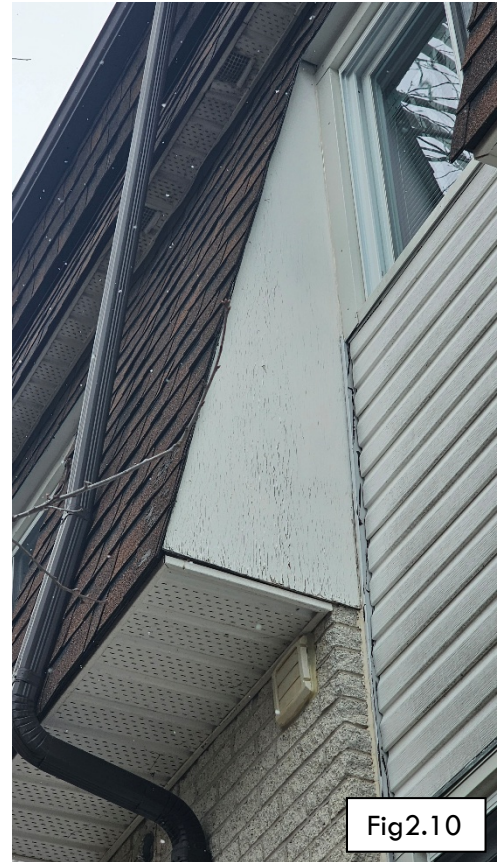
Fig2.10

Soffits have perforated venting (See Fig 2.10) and are in acceptable condition. Mansard fascia’s remain as painted plywood which is recommended to be covered with more durable product (ie metal flashing) is recommended before plywood degradation is beyond reasonable repair.

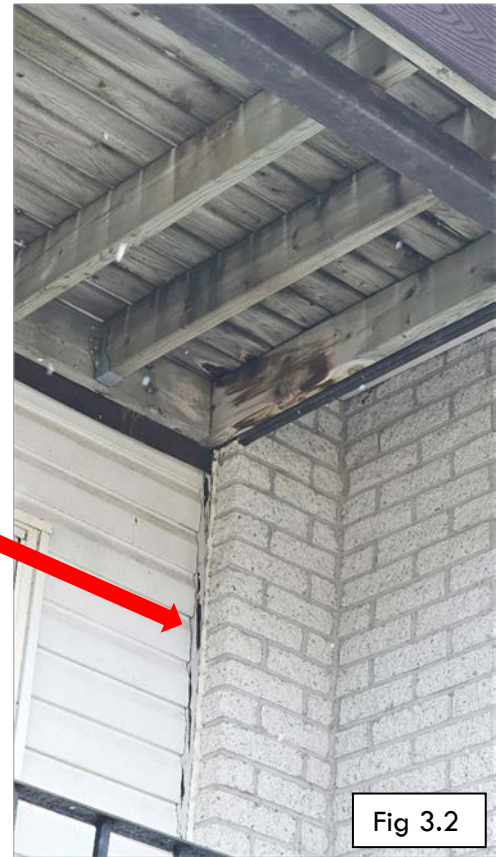
Fig 3.2

The exterior façade is comprised of primarily split face concrete brick masonry with panels of vinyl siding accents. The façade's appear to be in generally good condition with the exception of corner cracks noted under the structural commentary. The brick masonry is well pointed with proper rain-screen and weeping vents (See Fig 3.1) but could benefit from a good cleaning and sealing. The vinyl siding also could benefit from a good cleaning and the vinyl to masonry joints appears poorly caulked and require sealant (See Fig 3.2).

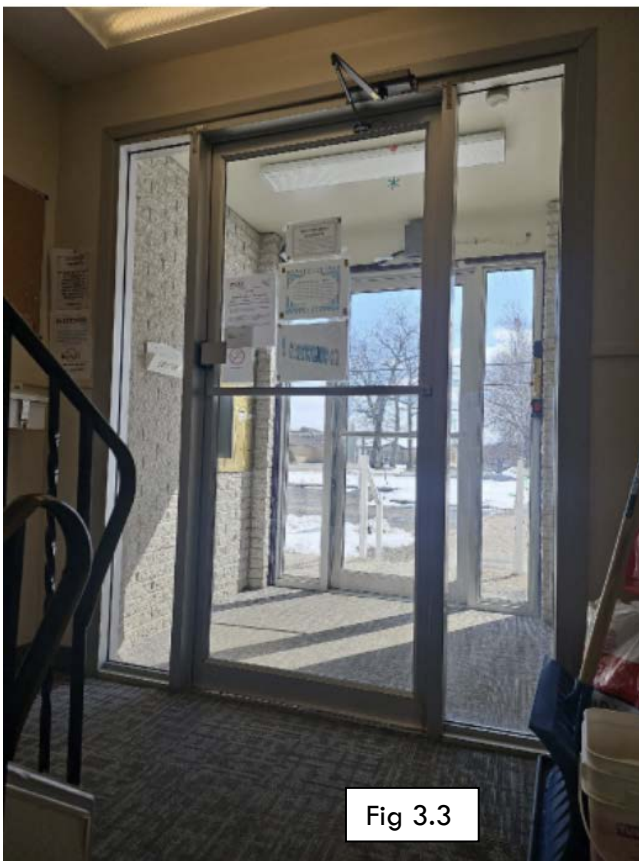
Fig 3.3

Exterior main entrances is a commercial aluminum entrance with side-lites (See FIG 3.3). The rear exit is a single aluminum door and frame. Both entrances were found to be operating as intended..

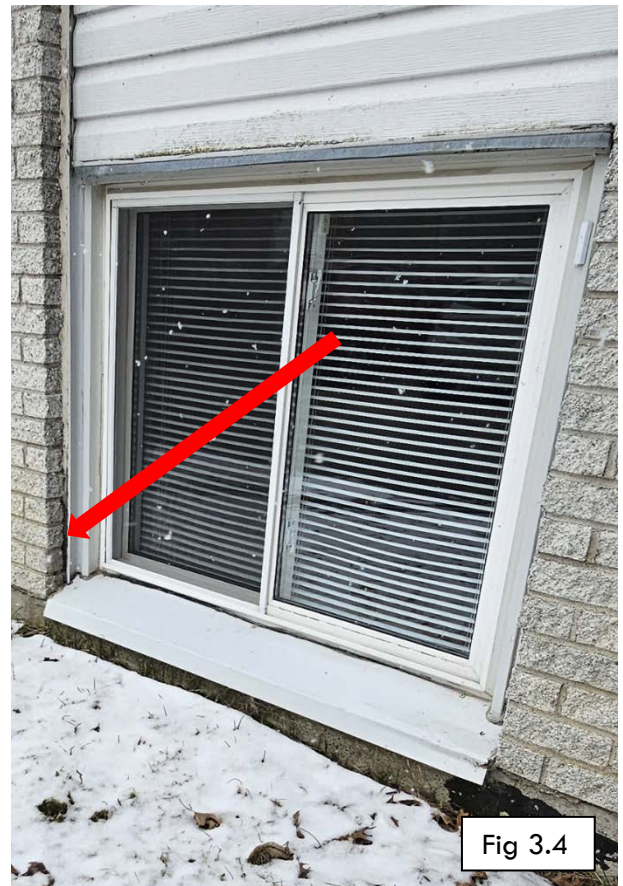
Fig 3.4

Windows are residential style Vinyl sliders manufactured circa 1991. Vinyl windows have a recommended 30 year life span and are therefore beyond their projected life span. Although the windows remain in acceptable condition and are not showing any signs of failure, they are not compliant with current codes of practice (NECC and NBCC 2015). Window sealants have also failing and are in need re-sealing with a good quality Poly Urethane sealant (See FIG 3.4).

- Exterior windows require immediate maintenance with added sealants
- Vinyl Siding should be cleaned and treated for UV protection and inspected annually for sealants and degradation.
- Vinyl windows should be budgeted for replacement
- Plywood fascia's are recommended to be covered with metal to prolong life-span
- Parking surface patching and sealant, recommend budgeting resurfacing within 5 years

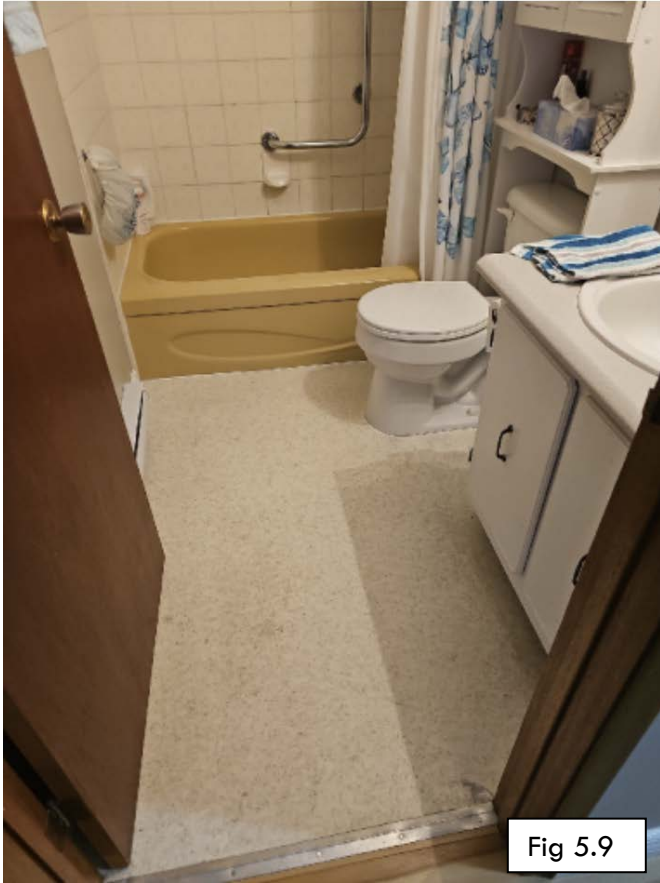
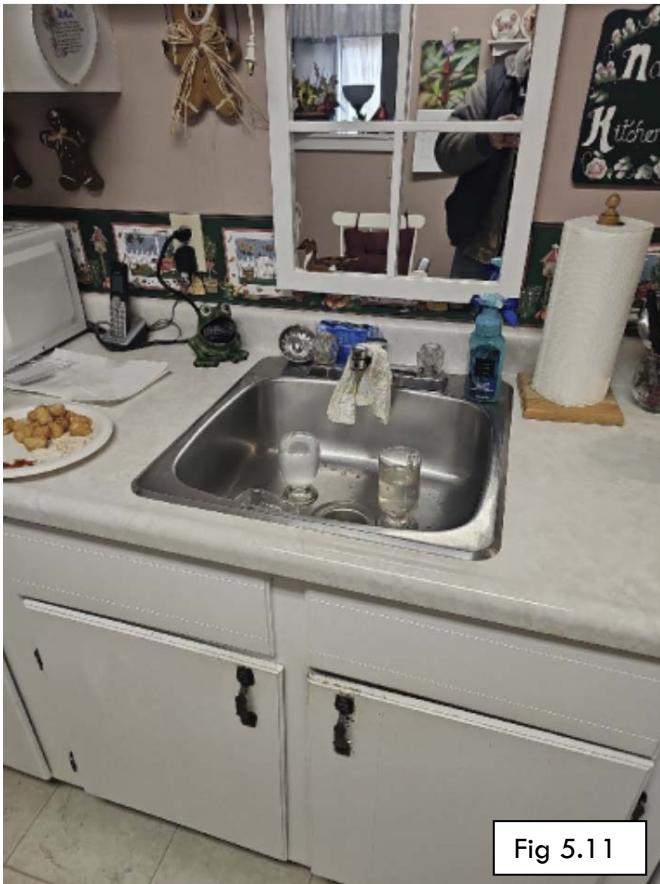
Plumbing fixtures were identified as a mixture of original (See Fig 5.9, 5.11) and replacement fixtures (See Fig 5.10). The original equipment is of poor aesthetic condition but remains functional.

- Fixture upgrades should be budgeted for ~ 75% of the facility.
- Pipe insulation should be installed over exposed hot and cold-water lines for efficiency and to prevent condensation.
- Water entrance service room requires 1 hr fire rating with rated access door.

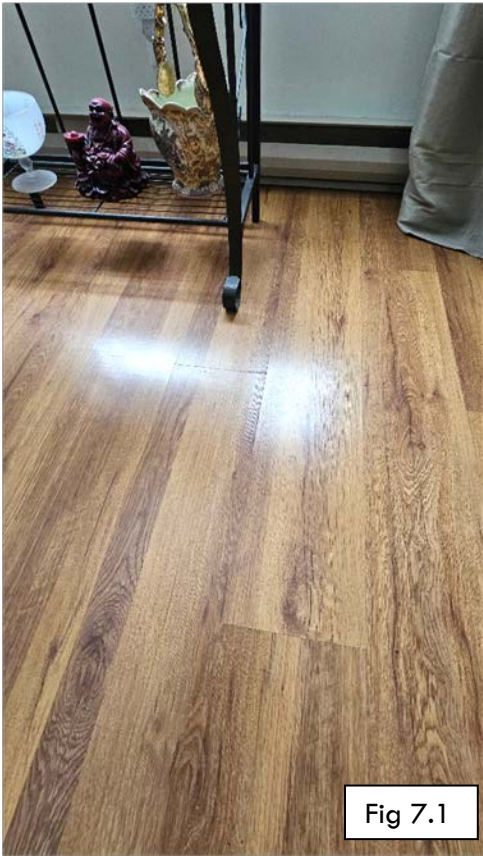
Fig 7.1

Flooring – Several units have upgrades which include newer laminate flooring installations (See FIG 7.1). Based on interviews with maintenance personnel, approximately 35% of the units are estimated to require upgrades which includes new flooring installation (See FIG 7.2). These non-renovated units contain older product which has a very dated appearance and is showing signs of wear. Unit 10 flooring had separating joints. Investigation showed higher than normal moisture readings (See FIG 7.3). It is suspected that the tenant is using excessive water to mop the floors causing swelling of the floor planks which led to its damages.

- Upgrade flooring in non-renovated units

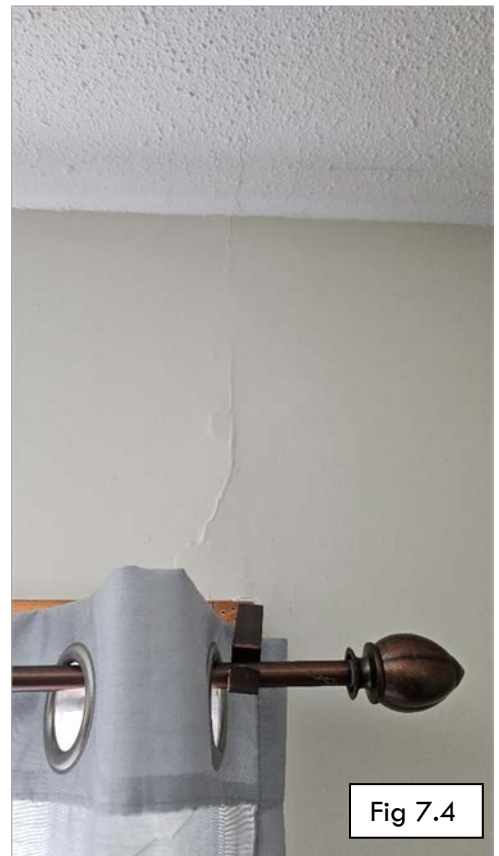
Fig 7.4

Walls - The walls throughout are painted gyprock and are generally kept in reasonably good repair. A few units were under renovation at the time of inspection. Of primary concern are areas of wall cracking (See Unit 23 FIG 7.4) and wall to ceiling connections where cracking and separation was identified (See Unit FIG 7.5 & Structural commentary). Moisture reading along visible cracks did not read “Wet” but were of significantly higher moisture content than surrounding wall surfaces (See FIG 7.6). The tape is also delaminating around the wall cracking (See FIG 7.7) which is often a result of moisture.

- Investigate observed wall cracking for possible structural movement
- Investigate for water infiltration at areas of higher moisture content
- Investigate wall to ceiling separations visible in various units primarily along living room to kitchen walls.

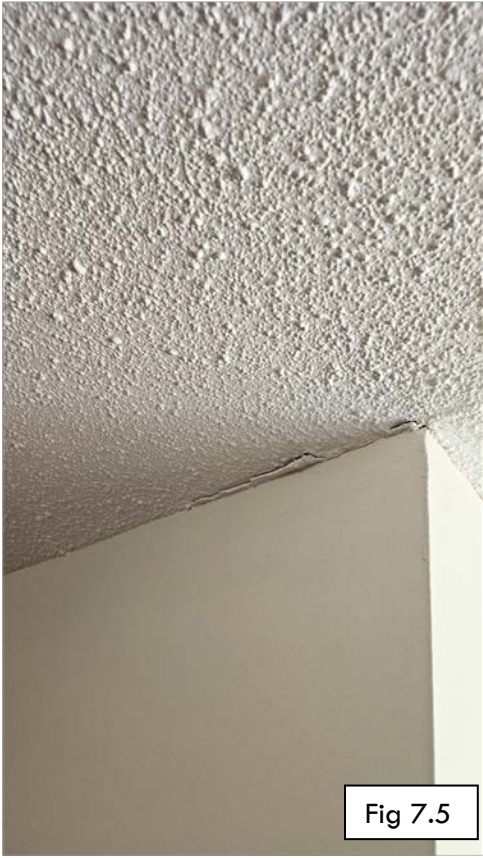
Fig 7.5

Ceilings - Ceilings are painted gyprock with textured spray finish (See FIG 7.5). The applied finish is difficult to match and therefore any areas of required repair tend to remain very noticeable.

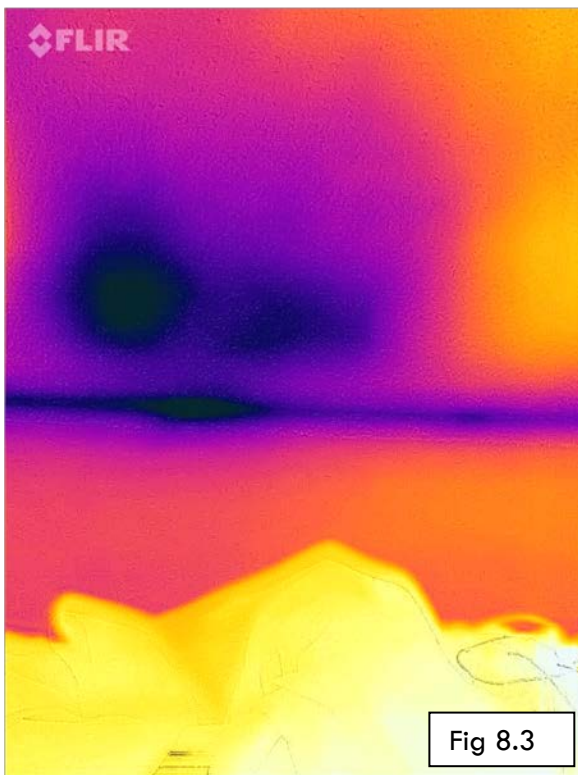
Fig 8.3

A critical component for a healthy environment is insulation and vapor barrier components. The wall assembly is inspected using moisture sensors and an IR Camera. The walls revealed several small cold zones at structural components and connections (See Example FIG 8.1). The wall system is non-compliant in its thermal transmissivity which is very noticeable with the IR Camera (See FIG 8.2). Attic insulation R-values are also non-conforming with <R20 values and areas of wet/missing insulation were noted (insulation which was or is wet will also lose R-value and show as cold zone) (See FIG 8.3).

- R-values are non-conforming to present NBCC 2015 building code. R-Value Improvement is recommended
- Fresh air HRV system is recommended in each unit and common areas (See mechanical commentary)
- Investigate walls beneath window for signs of rot or water infiltration

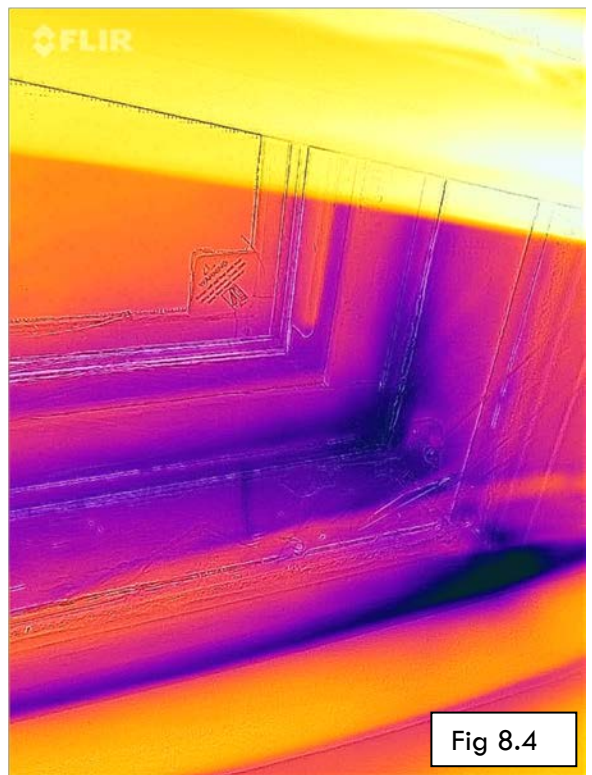
Fig 8.4

Windows show signs of cold infiltration around perimeters and trims. Air movement could also be felt in these zones (See FIG 8.4). Windows are expected to be “chinked” (stuffed with FG Batt insulation) based on age of construction which allows infiltration and air movement. An attempt has been made to seal the windows from the exterior with caulking which helps but this does not stop wind pressure from causing infiltration. Low expansion PU foam insulation is recommended around windows. Given the age of windows and building construction, a closer invasive investigation of a random selection of wall assemblies around and beneath windows is recommended to ensure no structural rot is present. The unit identified with cracked drywall would be one that is recommended for closer investigation.

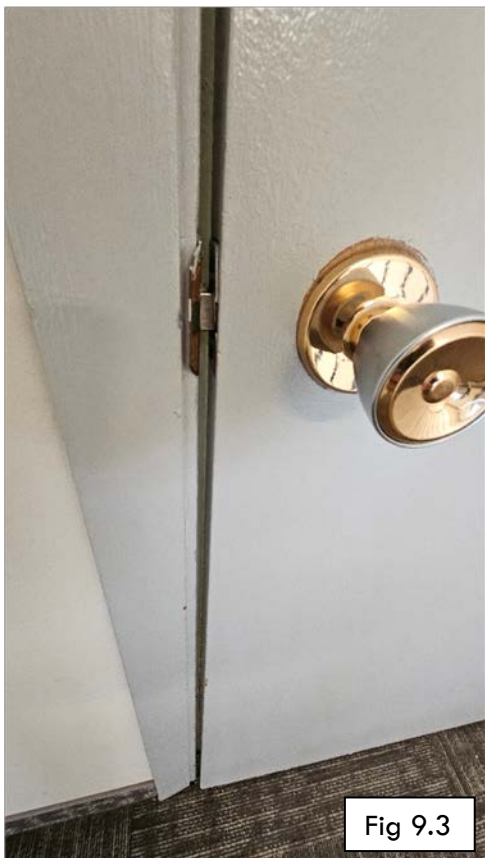
Fig 9.3

Exit Doors into stair-wells are required to self-close and provide fire rated separation and smoke seal. Doors were found to not latch properly or completely seal off openings (See FIG 9.3).

- Replace Unit Entry doors with ULC Rated Entries (Recommend Safe-n-Sound doors)
- Replace stair-well door with new properly rated doors and frames with self-closing hardware.
- Install appropriate fire barriers to all penetrations of rated rooms service.
- Accessibility and Barrier free requirements are not satisfied
