BUILDING CONDITION ASSESSMENT

1/29/2025

95 Sunset Drive, Fredericton NB

PREPARED BY: G. Paul Dayton, P. Eng.

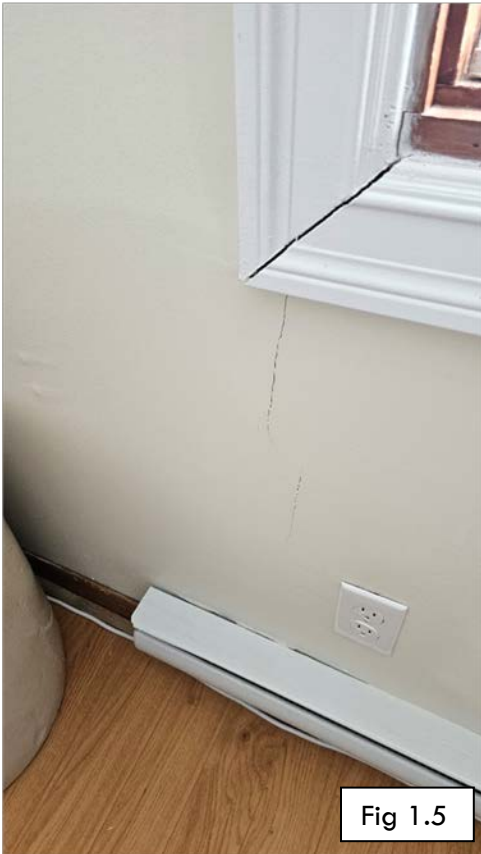
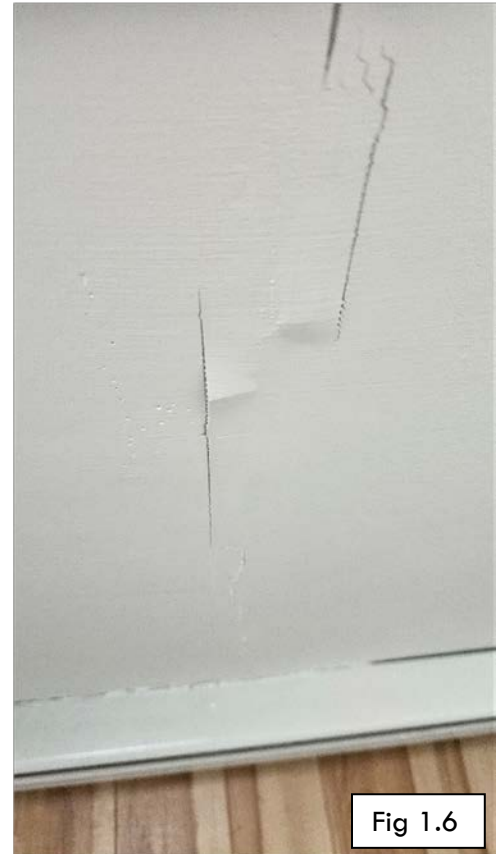
There were some signs of movement with significant cracking identified in the South-east corner of the facility (See Fig 1.5, 1.6) which may have some structural significance. Further invasive investigation is warranted to verify condition of structural components in these areas as they could not be verified due to concealment. There is also separation of ceilings from partition walls (See Fig 1.7). This appears to be resulting from truss-uplift and is not deemed to be a serious structural concern. Cracking is also evident on the stair landing underside. There was no visible evidence of movement and this is assumed to have resulted from an impact.

- Further investigation of South-East corner cracking and movement is recommended to ensure that the exterior wall assembly is not structurally compromised.

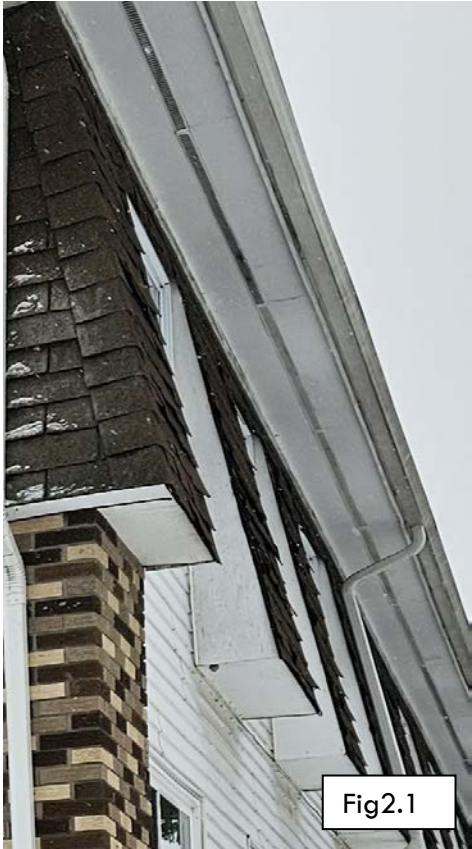
Fig2.1

Upper soffits appear metal with venting strip (See Fig 2.1). Mansard soffits are painted plywood (See Fig 2.1) and are in poor condition. Covering of painted plywood with more durable product (ie metal flashing) is recommended before plywood degradation is beyond reasonable repair.

Soffits and fasciae are painted plywood. The upper soffits appeared to be recently painted. Lower Mansard soffits and fasciae appear badly weathered and in need of maintenance (See Fig 2.1 & 3.5). Covering of the exposed plywood with metal flashings or similar is recommended to extend their life and prevent further decay.

- Mansard roof facing shingles due for replacement
- Cover painted plywood Mansard soffits with metal or similar facing to protect and extend life

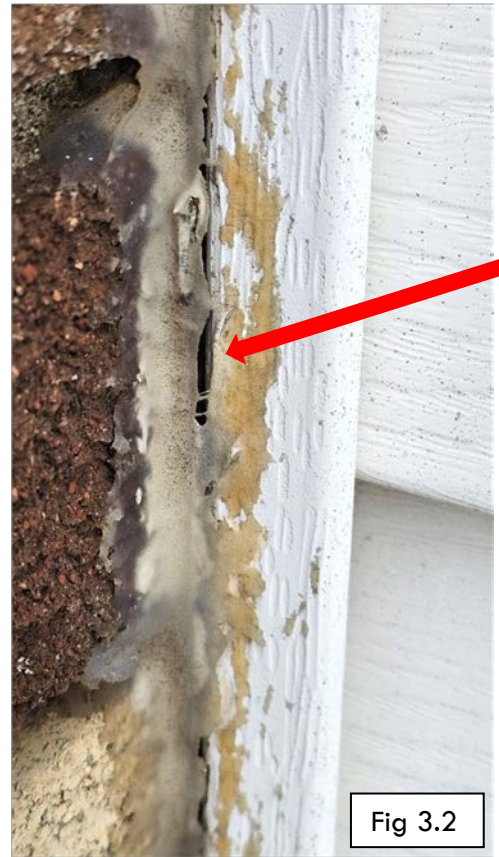
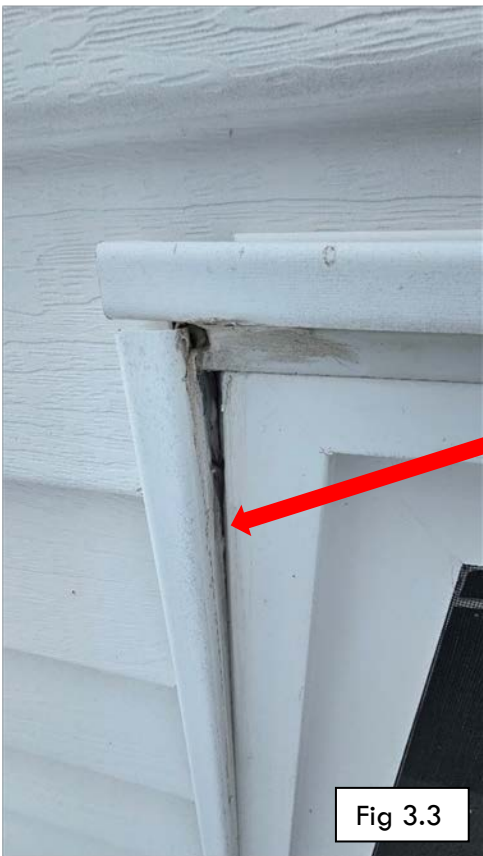
The exterior façade is comprised of primarily vinyl siding with large corner accents of colored brick masonry. The vinyl siding shows evidence of UV damage which is breaking down the material and causes the material to become brittle and chalky (See FIG 3.1). Maintenance advised that the vinyl siding and windows have been recently sealed with elastomeric sealant but there remains evidence of areas of separation (See Fig 3.2, 3.3).

- Exterior windows require immediate maintenance with added sealants
- Windows should be budgeted for replacement
- Vinyl Siding should be cleaned and treated for UV protection and inspected annually for sealants and degradation. Replacement should be scheduled in the 5-year capital budget.
- Soffits and fasciae are recommended to be covered with metal to prolong lifespan
- Parking surfaces are due for replacement or topping
- Excavate and seal foundation leaks at electrical entrance

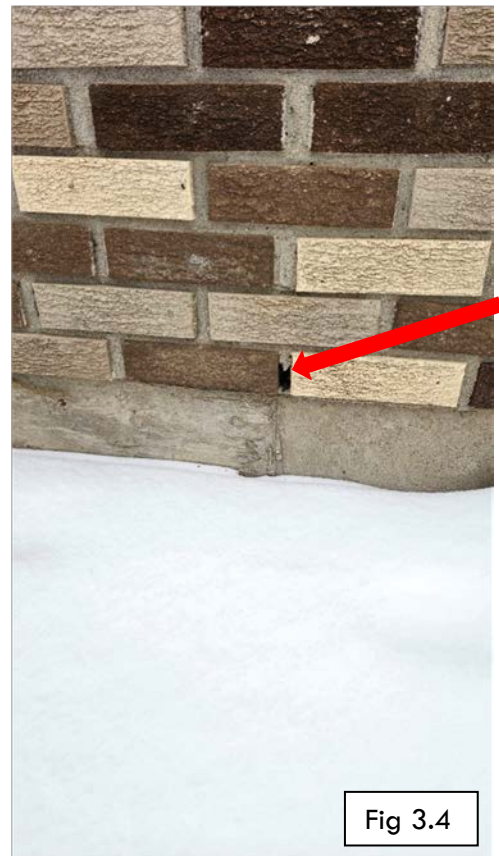
Fig 3.4

There is brick masonry accenting each corner. Masonry was found to be in good repair with proper weeping (See Fig 3.4).

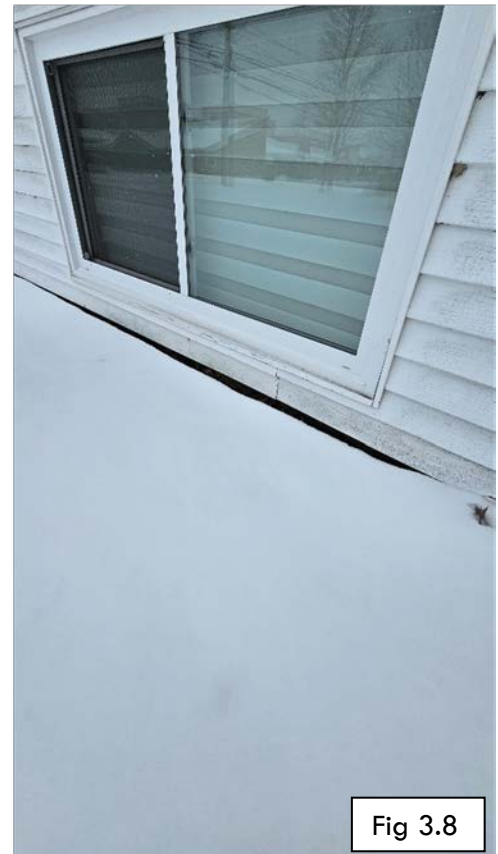
Fig 3.8

Windows are residential style Vinyl slider windows (See FIG 3.8). The windows are at their projected life span but are not showing any signs of failure. There are signs of condensation on some sills (See 1.7 Interior Commentary)

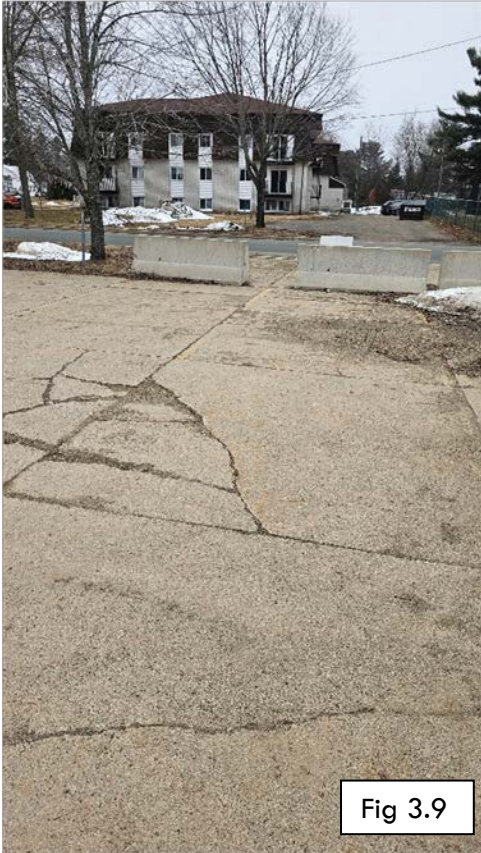
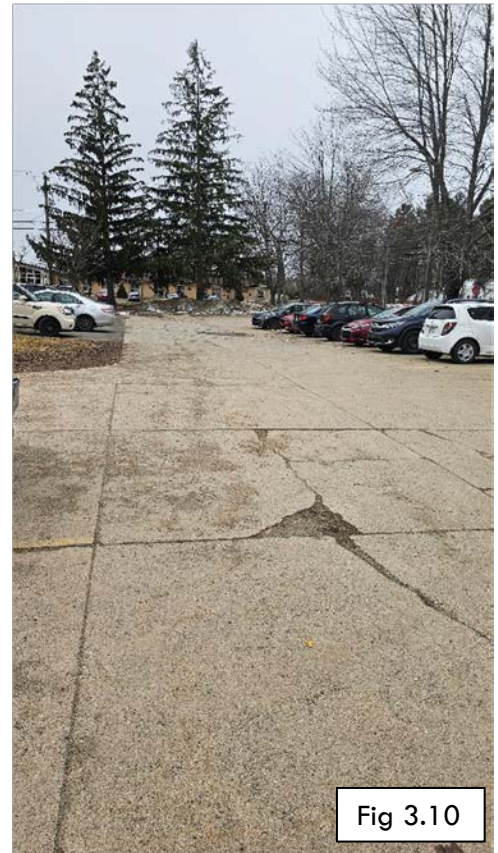
Parking surfaces are constructed of reinforced-concrete slabs. The concrete is showing signs of degradation with some significant cracking and differential settlement. Surfacing should be scheduled for replacement or application of an asphalt topping if grades permit (See Fig 3.9, 3.10).

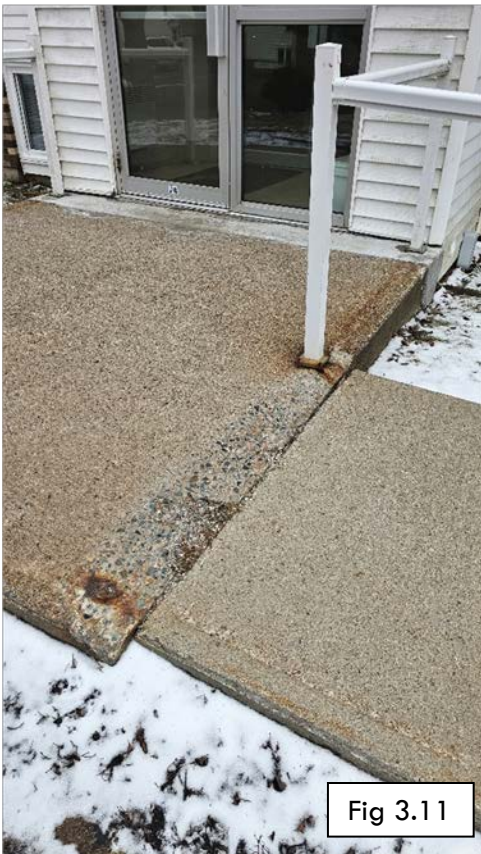
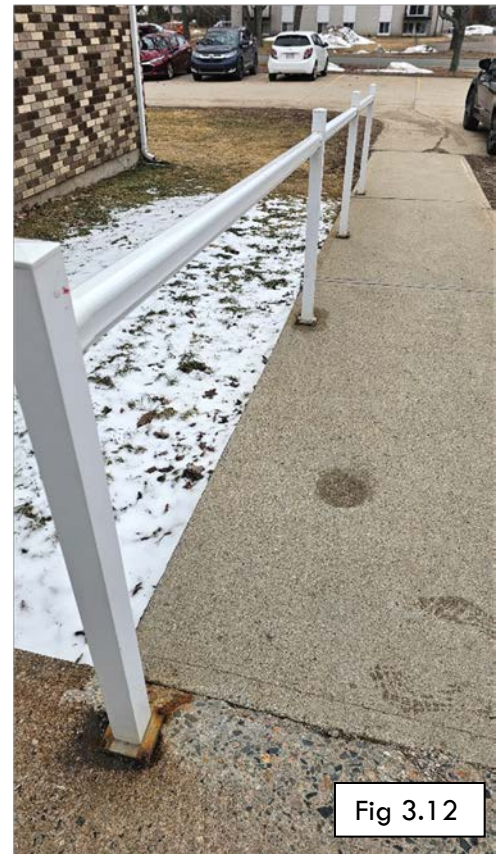
Sidewalks were found to be in poor condition with significant settlement and raised edges. Some repairs have been attempted to improve safety, but edges are too abrupt and non-conforming (See Fig 3.11 & 3.12).

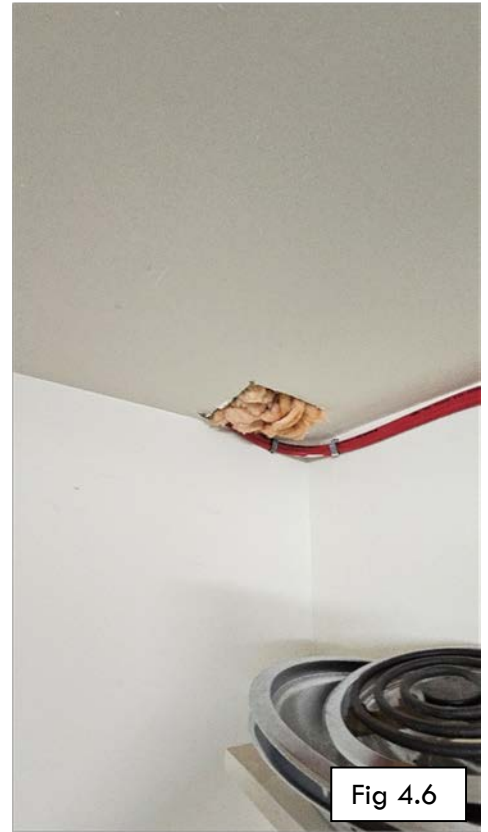
Fig 4.6

The electrical room penetrations do not have conforming fire protection at penetrations (See FIG 4.6, 4.7) which is required for code conformance (See 1.9 Life Safety).

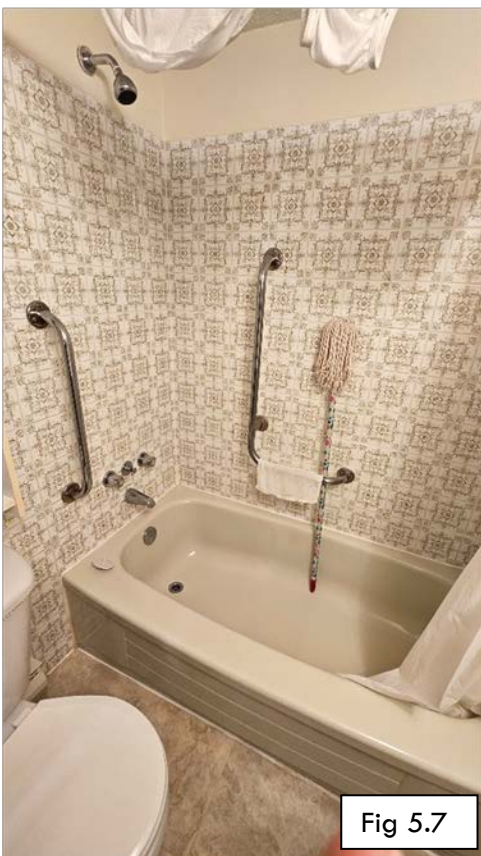
Fig 5.7

Plumbing fixtures were identified as a mixture of newer replacements (See Fig 5.6) and original equipment of poor aesthetic condition (See Fig 5.7) but remain in good functional repair.

- Fixture upgrades should be budgeted for ~ 25% of the facility.
- Pipe insulation should be installed over exposed hot and cold-water lines for efficiency and to prevent condensation.

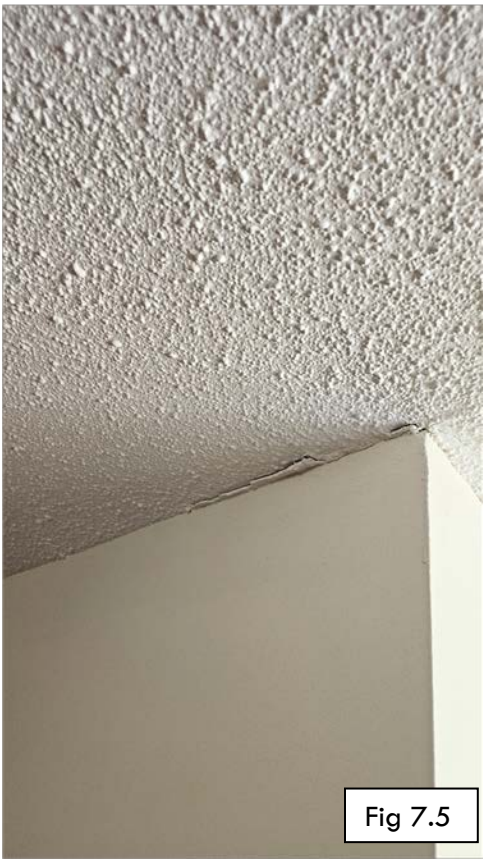
Fig 7.5

Ceilings - Ceilings are painted gyprock with textured spray finish (See FIG 7.5). The applied finish is difficult to match and therefore any areas of required repair tend to remain very noticeable.

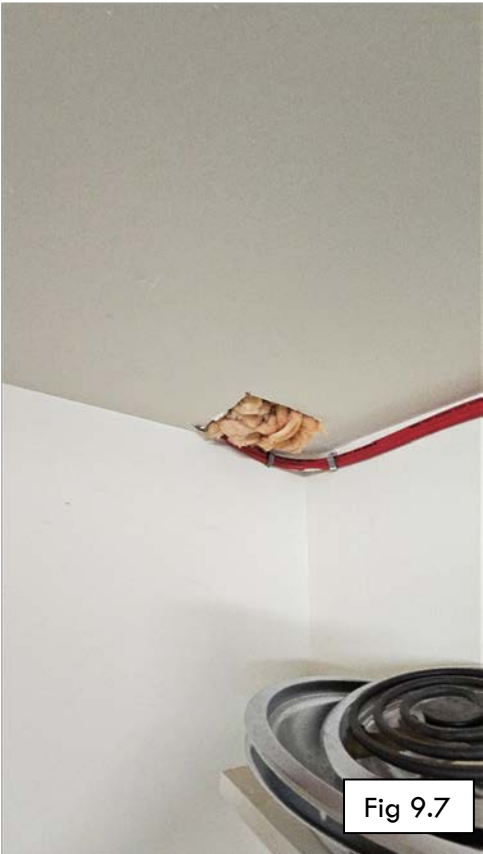
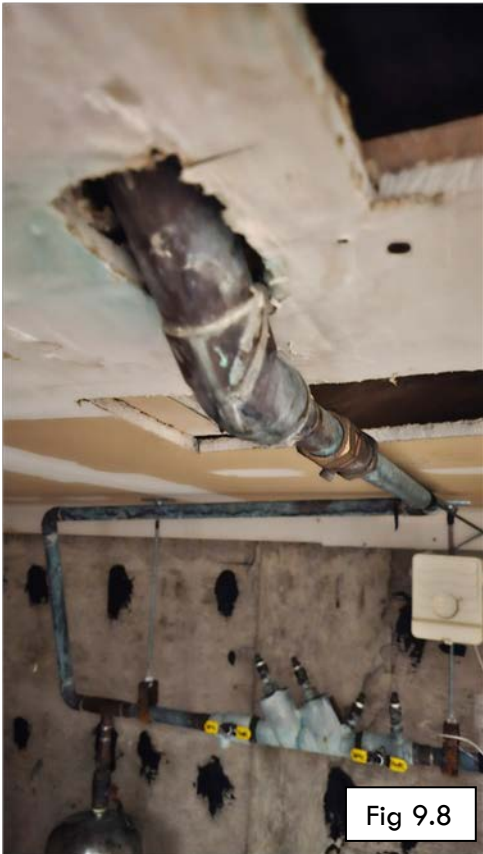
Service areas require fire separations of 1 hour rating. Several penetrations were identified which require patch and repair and application of approved fire sealants or collars (See FIG 9.7-9.8)

- Replace Unit Entry doors with ULC Rated Entries (Recommend Safe-n-Sound doors)
- Replace stair-well door with new properly rated doors and frames with self-closing hardware.
- Install appropriate fire barriers to all penetrations of rated rooms service.
