BUILDING CONDITION ASSESSMENT

4/22/2025

120 Sunset Drive, Fredericton NB

PREPARED BY: G. Paul Dayton, P. Eng.

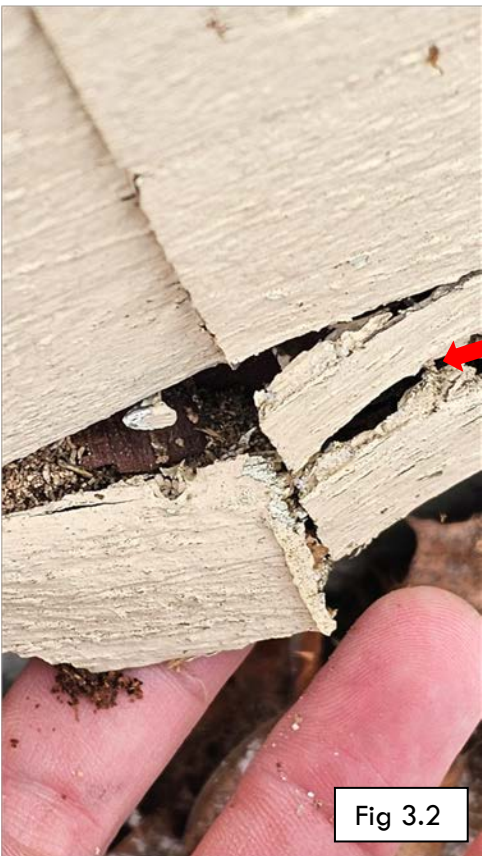
Fig 3.1

The exterior façade is comprised primarily of Brick Masonry and wood siding with large corner accents of colored brick masonry (See FIG 3.1). There is also a small amount of Hardi-plank cement siding on the North-West end of the building. Hardi-plank was recalled for some time due to the breakdown of the products binders before being reformulated into the new product line. Based on the era of installation it is possible this is from the original discontinued product line. The wood siding is showing significant evidence of absorption with areas of significant rot (See Fig 3.2-3.3). There is concern of possible water damage and rot in the exterior wall cavities due to the damage noted on the siding. Further investigation is recommended into the interior condition of the exterior walls.

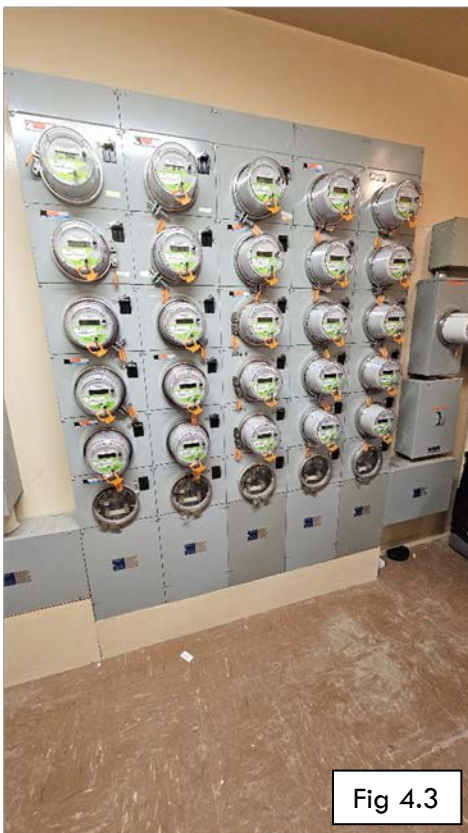
Fig 4.2

The building electrical system is supplied from a pad mount transformer on the North-East side of the building between Sunset Drive and the building (See Fig 4.1). The main service is a 120/208V 600 Amp 3Ø 4W service (See FIG 4.2 & 4.4). The building contains 25 meters (See FIG 4.2) which serve the individual units and 1 for the common areas. The main entrance is located on the North-East side of the facility in an electrical room serviceable only from the interior of the first level space.

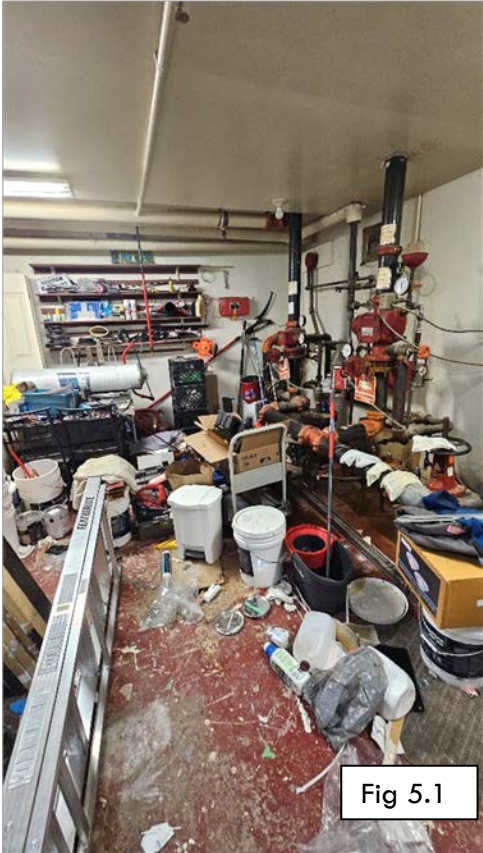
Fig 5.1

The facility is sprinklered with a 6" Cast Iron supply (See Fig 5.1). The domestic water supply is a 1" take-off from the main with a reduction to ¾" supply (See FIG 5.2). The waste service for the overall complex is provided via City of Fredericton Servicing. Annual inspections were labelled and current (See Fig 5.3).

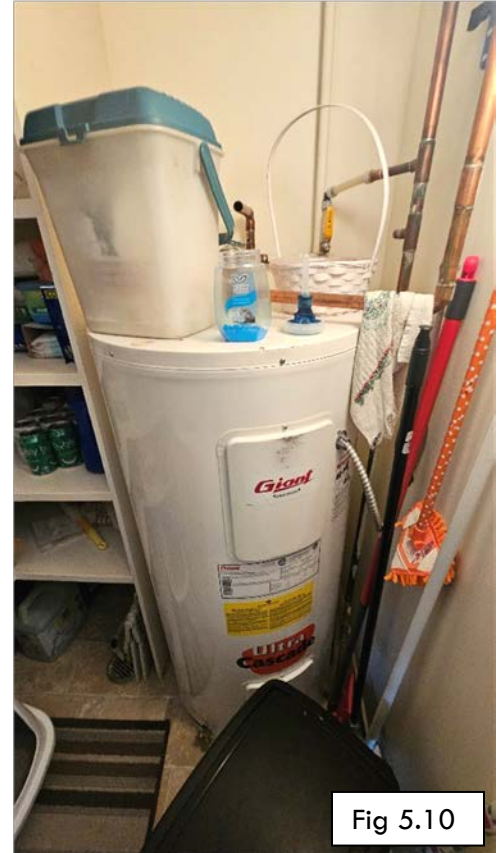
Fig 5.10

The domestic hot water is fed from individual 220V 40 Gal NB Power rental hot water heaters (See FIG 5.10) located in the storage/coat room in each unit.

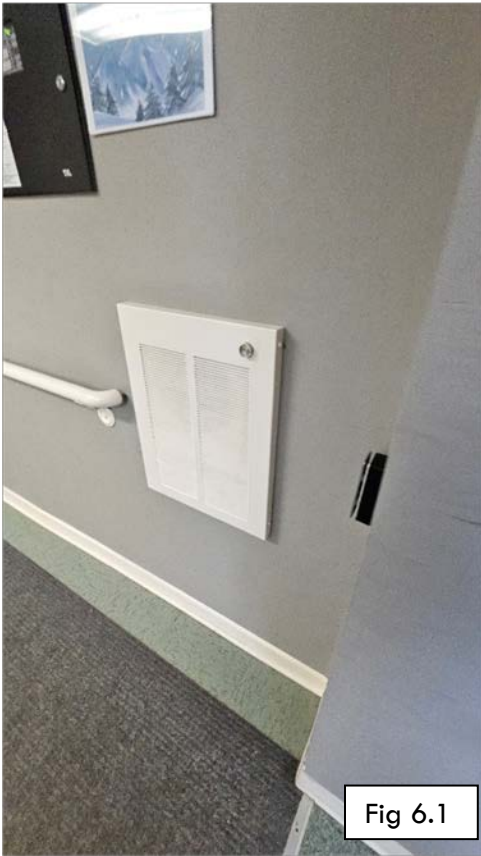
Fig 6.1

The heating source for this facility is provided by Electric Radiant Baseboard & Electric forced air heaters (See Fig 6.1, 6.2).

- HRV fresh-air systems are recommended for suites
- Independent Mini-splits are recommended for each suite to provide more efficient heating and add mechanical cooling for better comfort

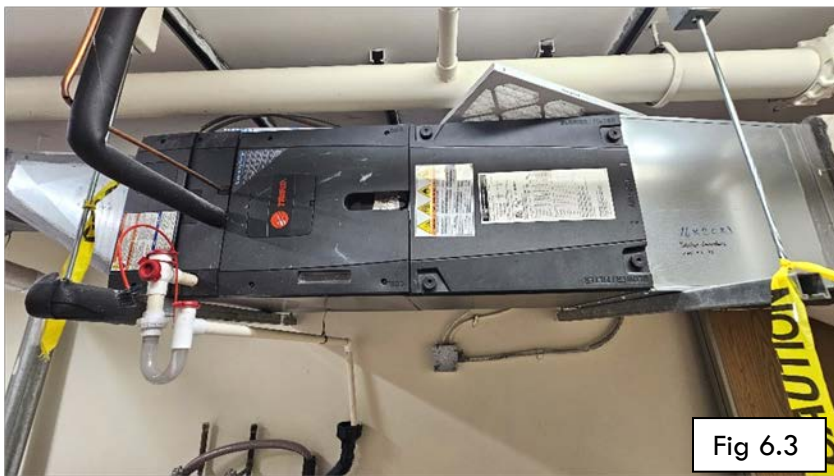
Fig 6.3

The common corridors are provided with mechanical cooling from a heat pump split system with AHU (Air Handling Unit) located in the Service/Laundry room (See FIG 6.3, 6.4). This unit was manufactured in 2017 and has a 22 year life expectancy.

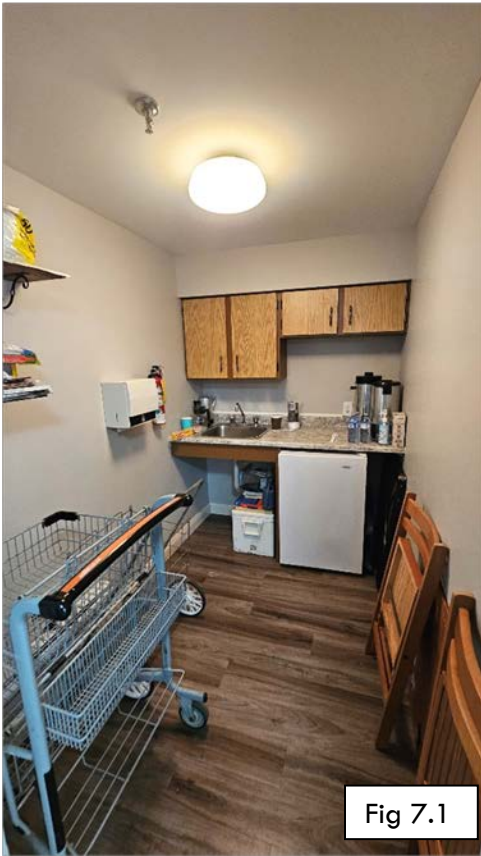
Fig 7.1

Flooring – Units were randomly inspected; finishes were found to be a mixture of newer laminates (See FIG 7.1 & 7.2) and older sheet vinyl flooring (See FIG 7.3). Sheet vinyl areas are very dated and recommended for replacement. Common areas were found to be primarily VCT in corridors with newer carpet at lobby/entry (See FIG 7.4 & 7.5). VCT remains functional with a few areas of cracking where floor substrate is uneven (See FIG 7.5)

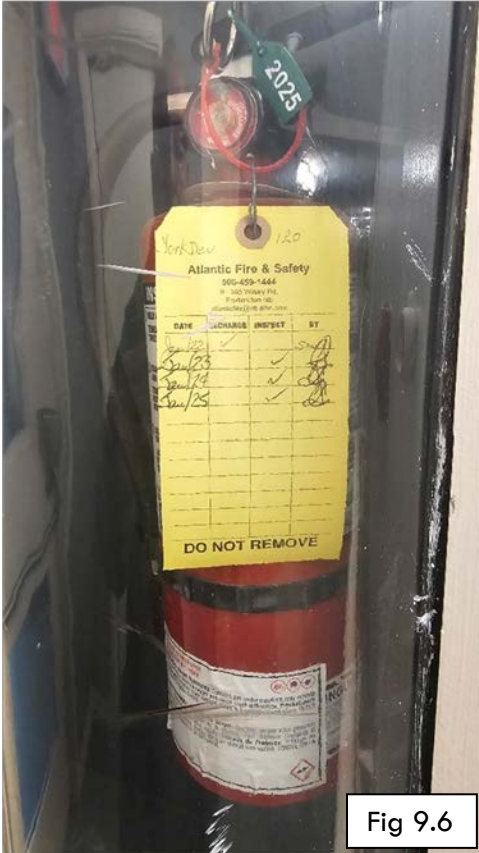
Fig 9.6

Fire extinguishers were present as required and testing is current (See FIG 9.6).
