BUILDING CONDITION ASSESSMENT

3/14/2025

91 Sunset Drive, Fredericton NB

PREPARED BY: G. Paul Dayton, P. Eng.

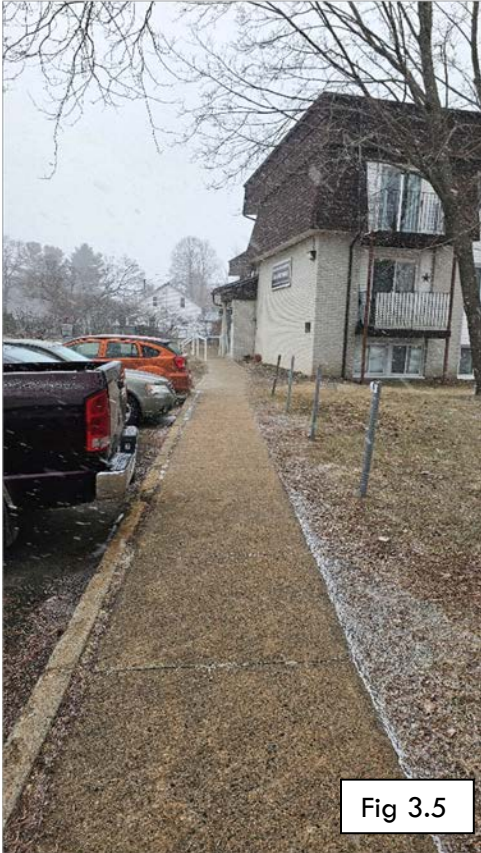
Fig 3.5

Sidewalks were found to be in weathered but functional condition (See FIG 3.5). Some portions of walkway have been replaced to maintain a level surface (See FIG 3.6). The rear stair and landing was found to be in very poor condition and in need of replacement (See Structural commentary for stair landing).

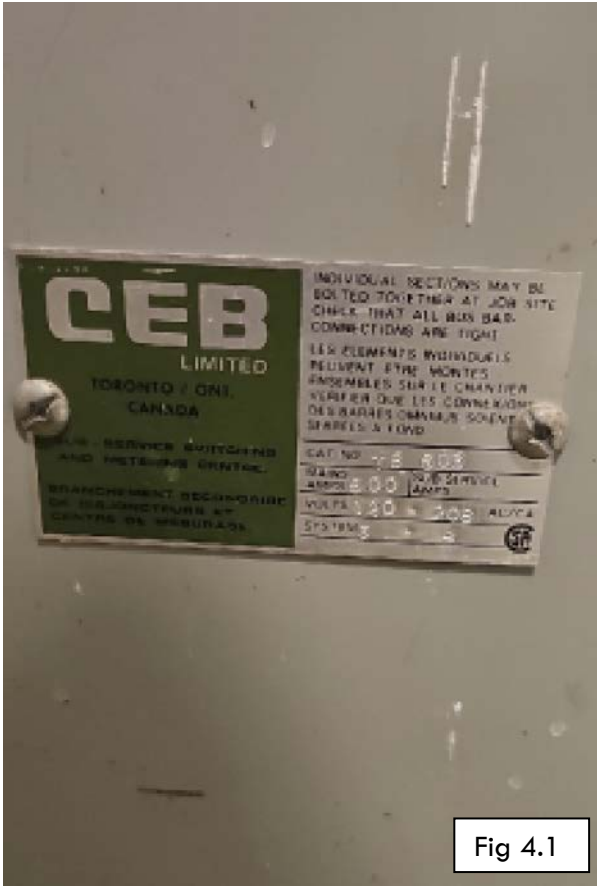
Fig 4.1

The building electrical system is supplied from a pole mount transformer to North side of the building. The main service is a 120/240V 600 Amp 3Ø service (See FIG 4.1). The building contains 24 individual meters (See FIG 4.2) and one House meter (See FIG 4.3). The service was installed Circa 1977 (See FIG 4.4). The main entrance is located on the North side of the facility in an electrical room serviceable only from the lower corridor.

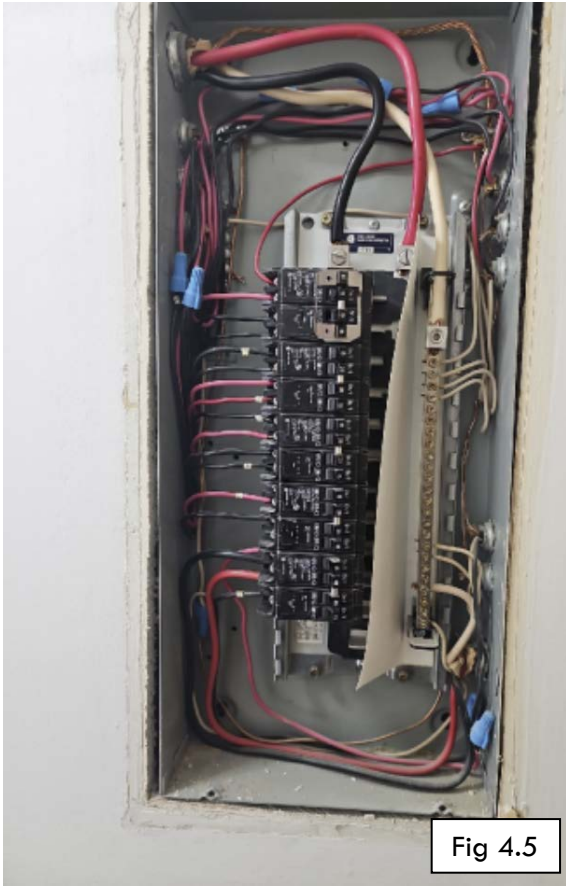
Fig 4.5

The wiring is modern properly rated material (See FIG 4.5) where visible and appears to be well managed throughout with labels, protected and concealed wire, and secured junctions.

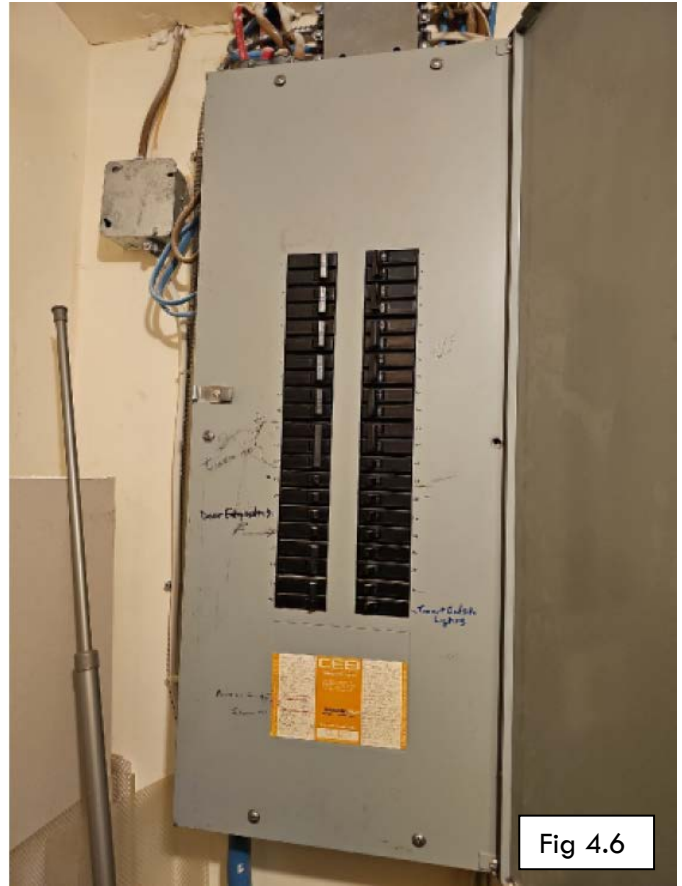
Fig 4.6

The service panels and sub-panels were randomly inspected and verified for proper wiring (See FIG 4.6) and no non-conformances were identified. Unit sub-panels are of type that is no longer readily available and may be necessary to upgrade as parts become unavailable.

- Panel upgrades may be required as breakers become more difficult to obtain for older systems.
- Upgrade worn receptacles

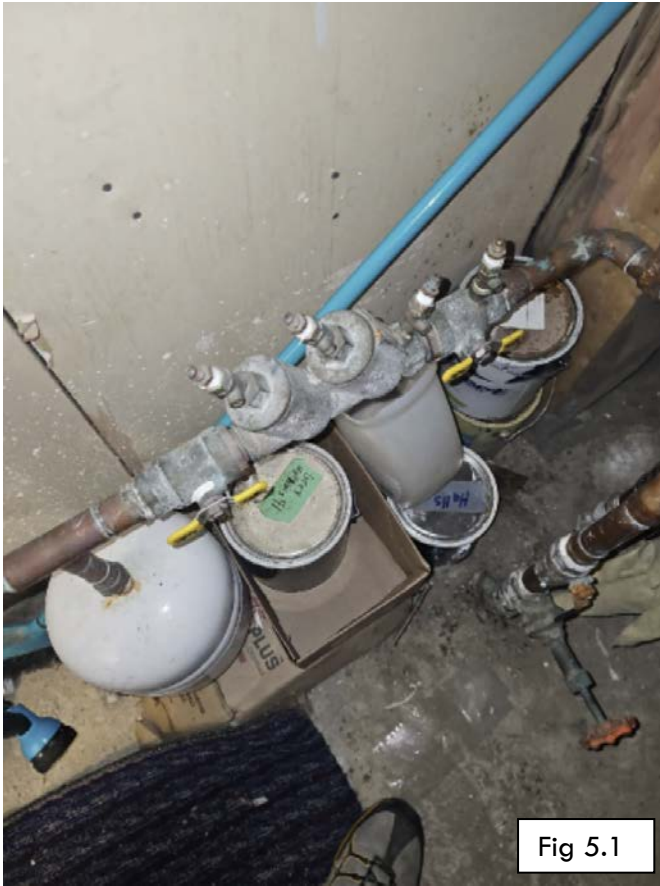
Fig 5.1

The domestic water supply and waste service for the overall complex is provided via City of Fredericton Servicing (See Fig 5.1). The scope of this investigation was limited to visual observation only. Water service is supplied through domestic copper piping where visible and shut-off valves were identified but were not tested (See Fig 5.2-5.3). The water meter testing was current and the certificate was present (See Fig 5.4).

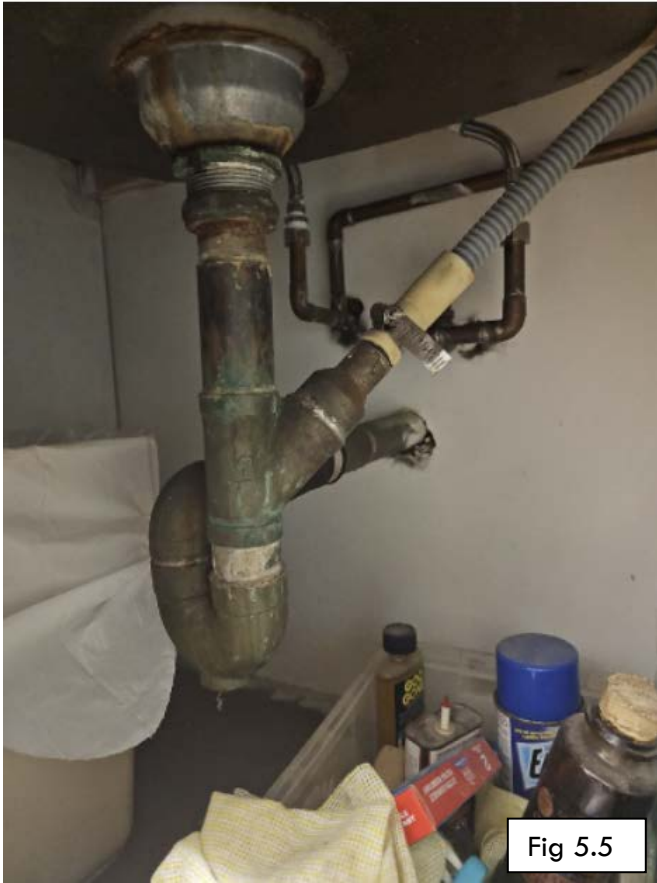
Fig 5.5

Waste piping is believed to be Cast Iron below grade and converts to primarily copper above grade (See Fig 5.5). Vent piping is also Copper (See Fig 5.6). Venting was extended through the new Mansard roof with ABS piping (See Fig 5.7) and some units have had plumbing converted to ABS Piping (See Fig 5.8).

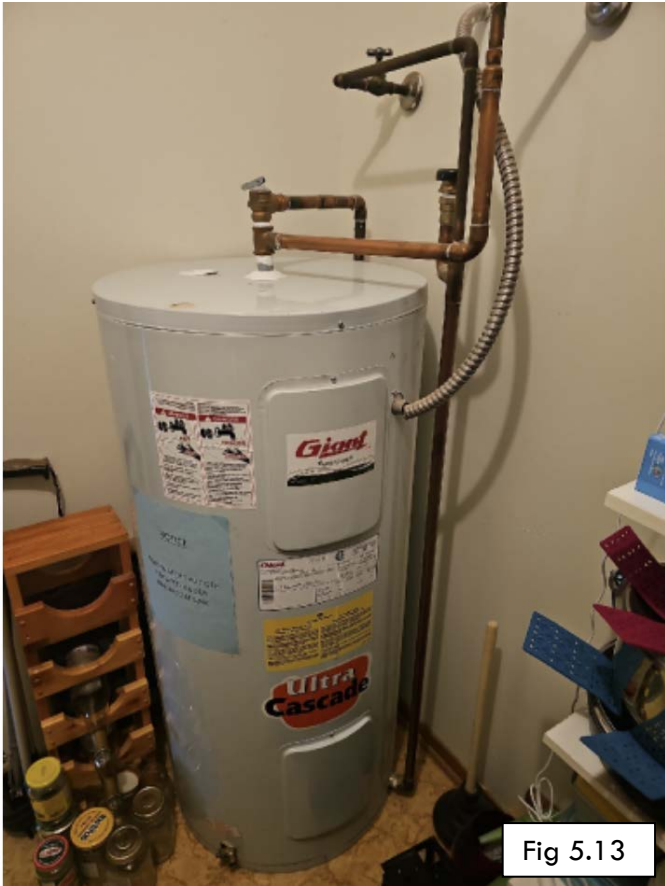
Fig 5.13

The rental units domestic hot water is fed from individual 220V 40 Gal NB Power rental hot water heaters (See FIG 5.13) located in hallway closets in each unit. Shared laundry facilities contain individual NB Power HW heaters also (See FIG 5.14).

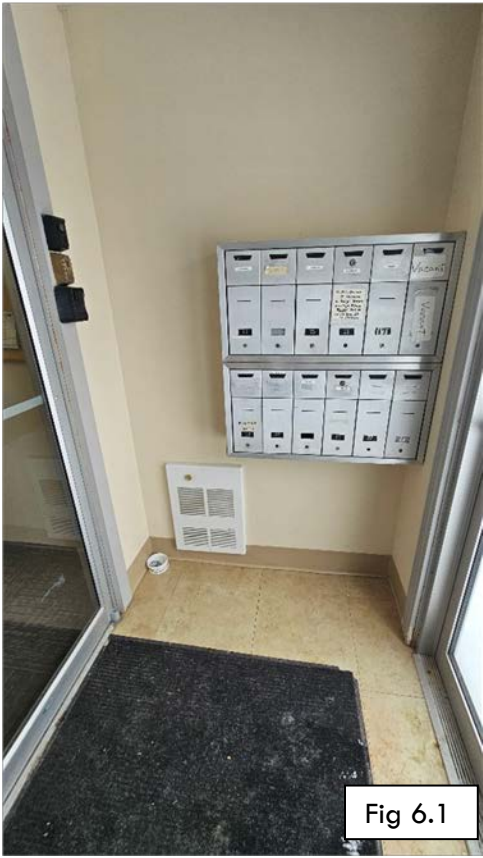
Fig 6.1

The heating source for this facility is provided by Electric Radiant Baseboard & Electric forced air heaters (See Fig 6.1, 6.2).

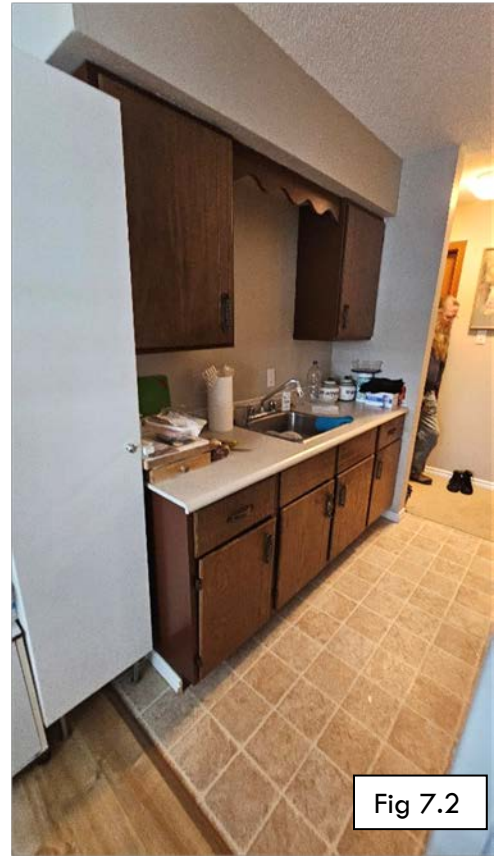
Fig 7.2

Flooring – Several units have upgrades which include newer laminate flooring installations (See FIG 7.1). Based on interviews with maintenance personnel, approximately 35% of the units are estimated to require upgrades which includes new flooring installation (See FIG 7.2). These non-renovated units contain older product which has a very dated appearance and is showing signs of wear. Unit 10 flooring had separating joints. Investigation showed higher than normal moisture readings (See FIG 7.3). It is suspected that the tenant is using excessive water to mop the floors causing swelling of the floor planks which led to its damages.

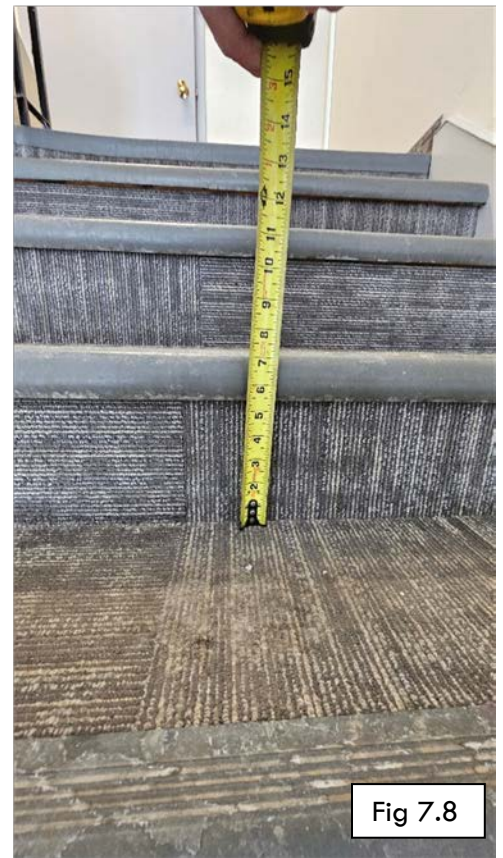
Fig 7.8

Stairs – Stairs are wood frame and are located on each end of the facility for exiting. The stairs do not conform to present day code requirements with excessive rise >7” and insufficient run (<11”) (See FIG 7.8, 7.9). Stairways are required to maintain a minimum headroom clearance of 2.08 m. Landing bulkheads restrict headroom to a non-conforming 1.93 m (See FIG 7.10). Stair railings are required to maintain continuous holding with wall clearances of 30 mm but railings are restricted to 12.7 mm at landing crossings (See FIG 7.11).

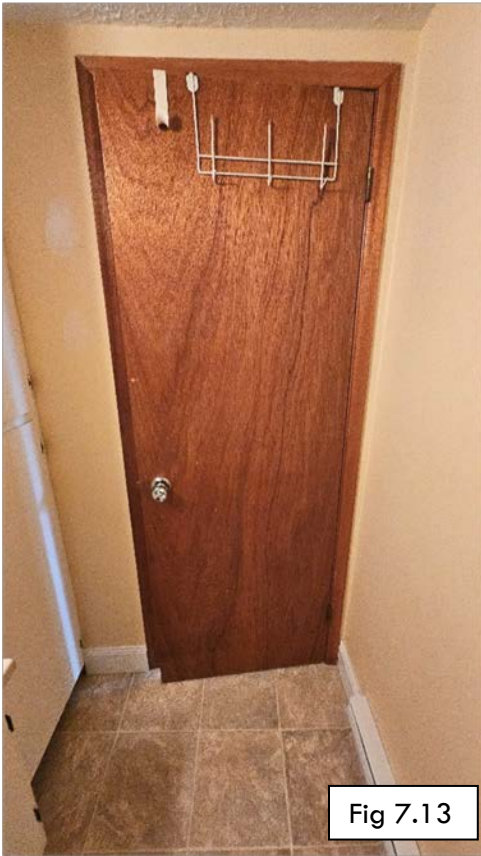
Fig 7.13

The interior doors are primarily wood veneer hollow core residential doors (See FIG 7.13) and remain functional but very dated in appearance. Door hardware appears to be original hardware of brass 1970’s styling. Unit entry doors are of poor sound quality and do not meet current fire rating requirements (See FIG 7.14). There were no UL ratings identified during inspections.

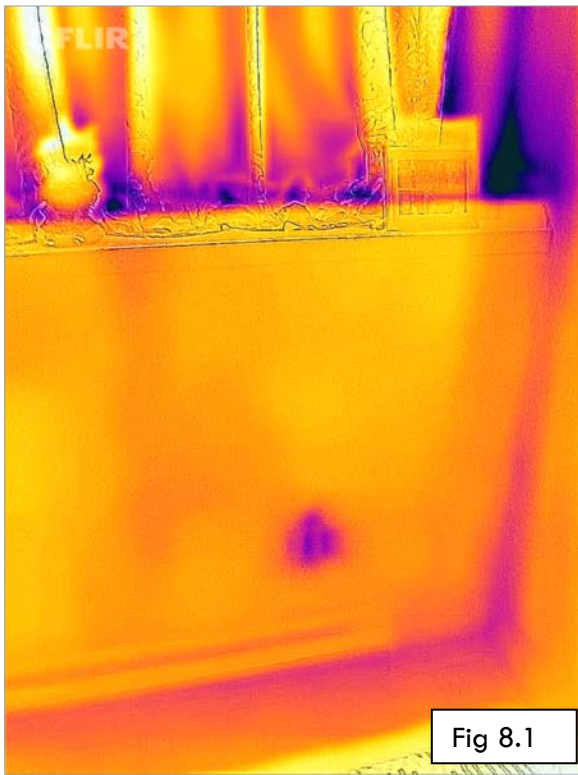
Fig 8.1

A critical component for a healthy environment is insulation and vapor barrier components. The wall assembly is inspected using moisture sensors and an IR Camera. The walls revealed several small cold zones at structural components and connections (See Example FIG 8.1). The wall system is non-compliant in its thermal transmissivity which is very noticeable with the IR Camera (See FIG 8.2). Attic insulation R-values are also non-conforming with <R20 values and areas of wet/missing insulation were noted (insulation which was or is wet will also lose R-value and show as cold zone) (See FIG 8.3).

- R-values are non-conforming to present NBCC 2015 building code. R-Value Improvement is recommended
- Fresh air HRV system is recommended in each unit and common areas (See mechanical commentary)
- Investigate walls beneath window for signs of rot or water infiltration

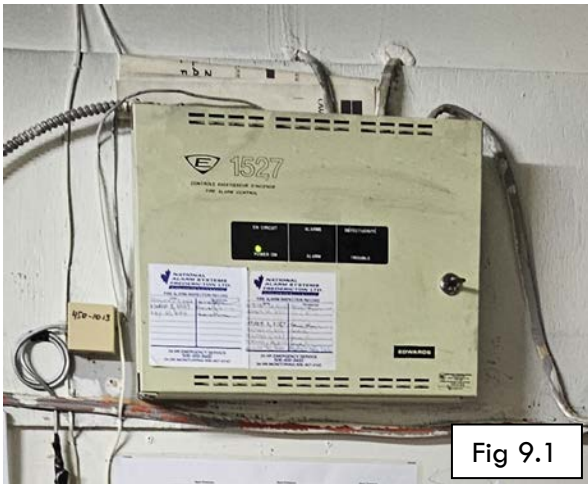
Fig 9.1

NBCC 2015 does not require a sprinkler system, however an addressable FA system is required. There is a certified and operational FA System in place (See FIG 9.1).

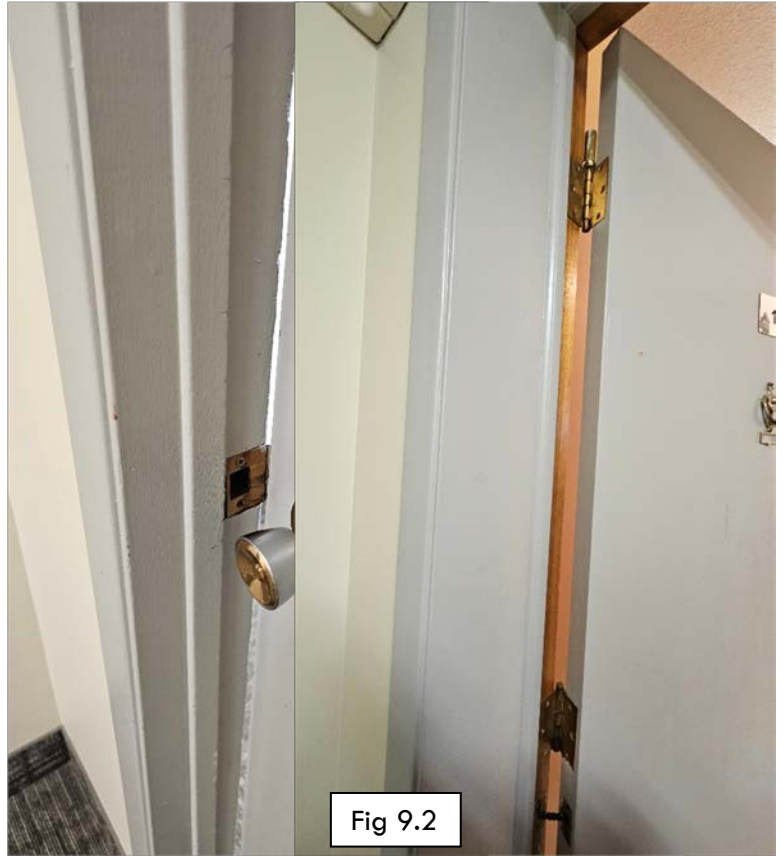
Fig 9.2

ULC Labelling was not present on entry doors or on stairwell doors or frames and are therefore non-conforming (See FIG 9.2).

- Replace Unit Entry doors with ULC Rated Entries (Recommend Safe-n-Sound doors)
- Replace stair-well door with new properly rated doors and frames with self-closing hardware.
- Install appropriate fire barriers to all penetrations of rated rooms service.
- Accessibility and Barrier free requirements are not satisfied

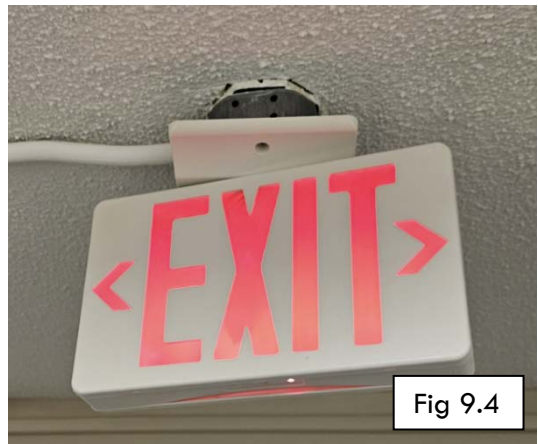
Fig 9.4

Emergency exits were clearly labelled (See FIG 9.4). Emergency lighting was tested and passed test circuit testing (See FIG 9.5).

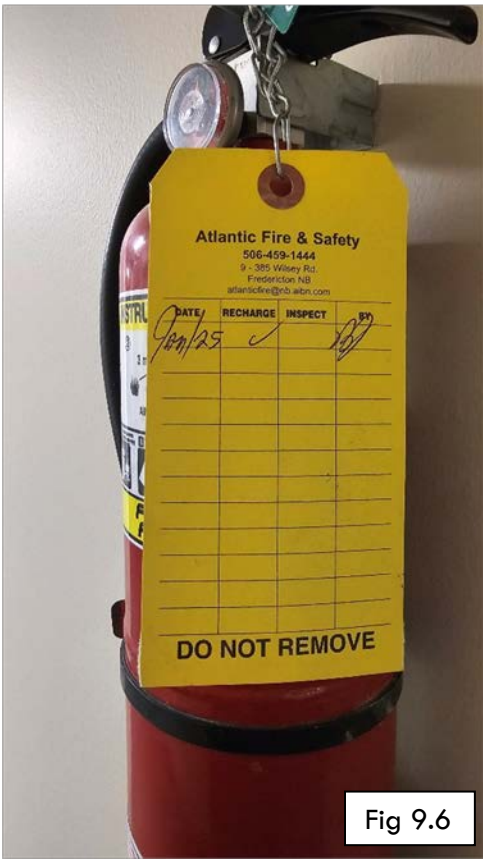
Fig 9.6

Fire extinguishers are present on each level and inspections are current (See FIG 9.6)
