BUILDING CONDITION ASSESSMENT

1/29/2025

95 Sunset Drive, Fredericton NB

PREPARED BY: G. Paul Dayton, P. Eng.

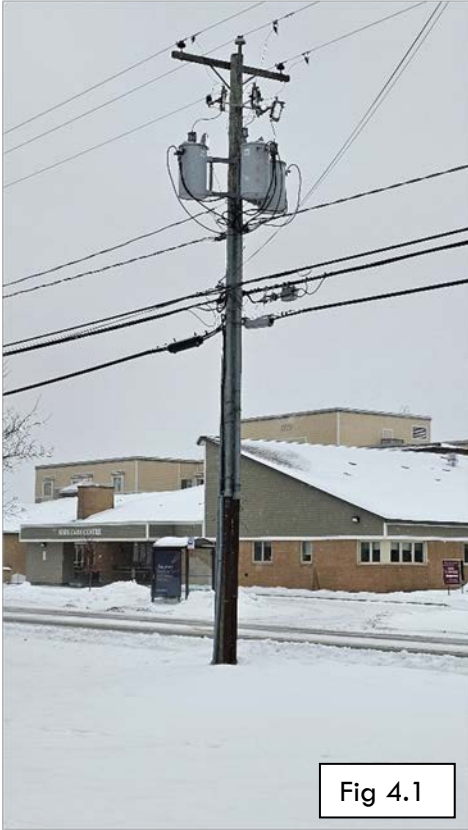
Fig 4.1

The building electrical system is supplied from a pole mount transformer to the rear of the building (See Fig 4.1). The main service is a 120/240V 600 Amp 3Ø service (See FIG 4.2). The building contains 24 meters (See FIG 4.2, 4.3) which serve the individual units and 1 for the common areas. The main entrance is located on the North side of the facility in an electrical room serviceable only from the interior of the first tenancy space. With multiple tenants this room should be directly accessible from the exterior without entering a tenant space.

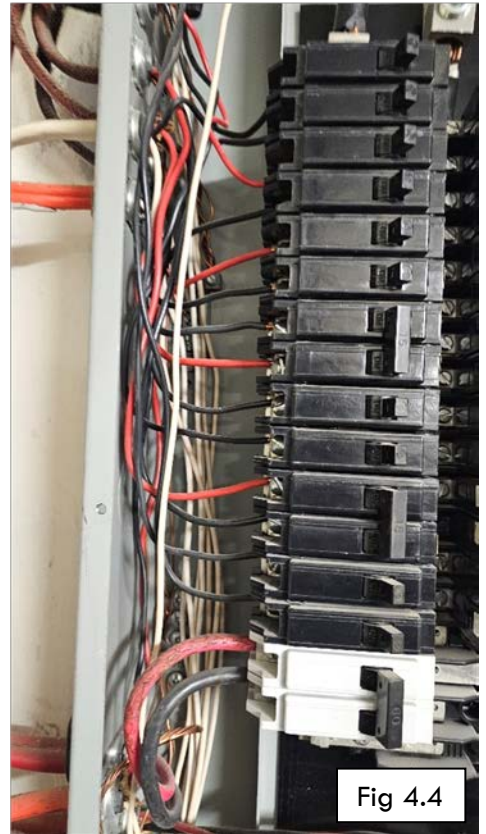
Fig 4.4

The service panels and sub-panels were randomly inspected and verified for proper wiring (See FIG 4.4, 4.5) and no non-conformances were identified.

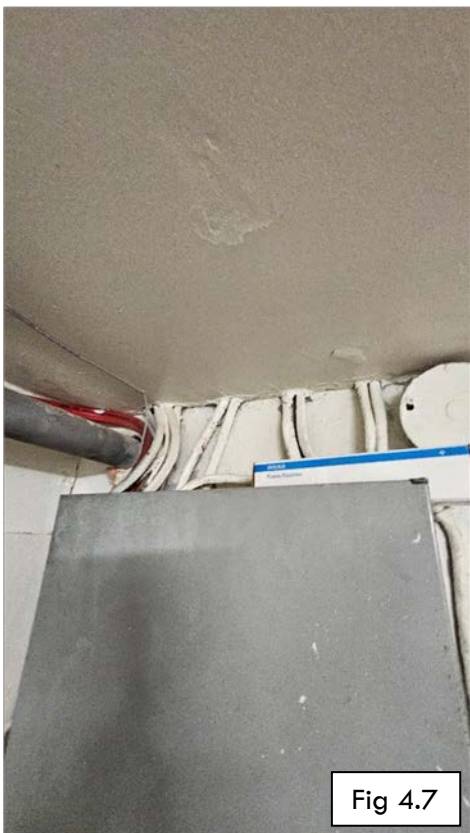
Fig 4.7

The electrical room penetrations do not have conforming fire protection at penetrations (See FIG 4.6, 4.7) which is required for code conformance (See 1.9 Life Safety).

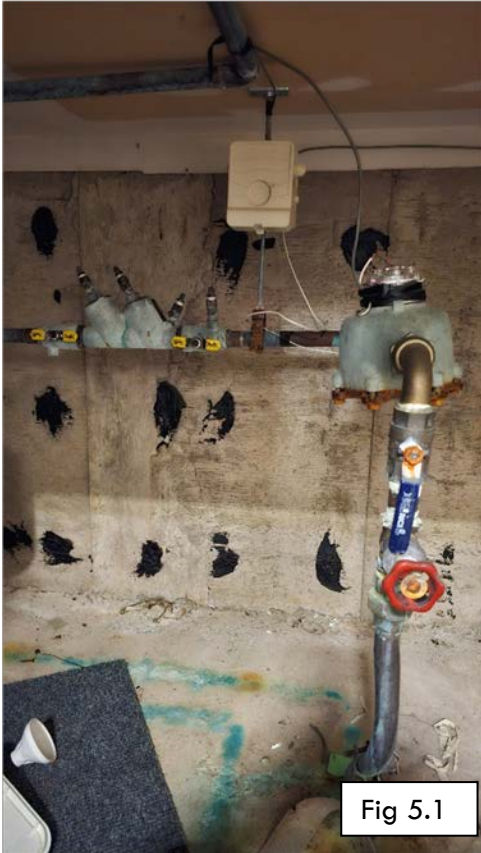
Fig 5.1

The domestic water supply and waste service for the overall complex is provided via City of Fredericton Servicing (See Fig 5.1). The scope of this investigation was limited to visual observation only. Water service is supplied through domestic copper piping where visible (See Fig 5.2). Waste-water piping was identified as Cast Iron below grade (See Fig 5.3). Portions of unit drainage and venting were identified as converted to ABS Piping (See Fig 5.4). The waste system venting is copper piping (See Fig 5.5).

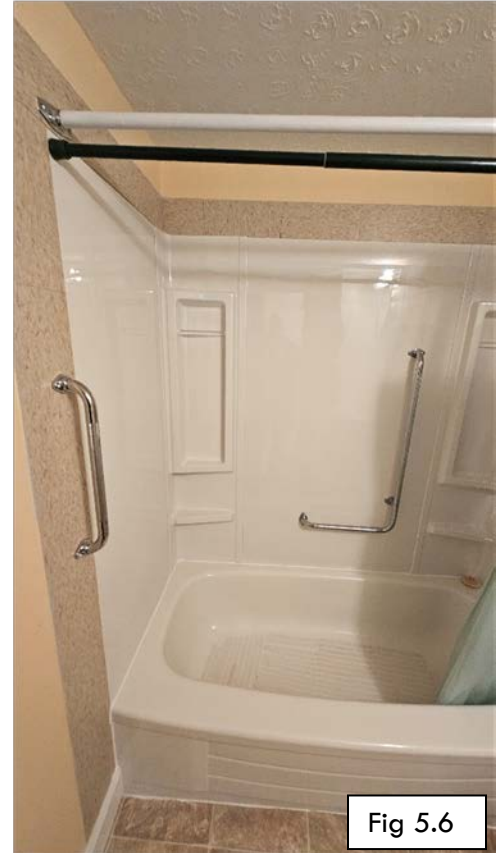
Fig 5.6

Plumbing fixtures were identified as a mixture of newer replacements (See Fig 5.6) and original equipment of poor aesthetic condition (See Fig 5.7) but remain in good functional repair.

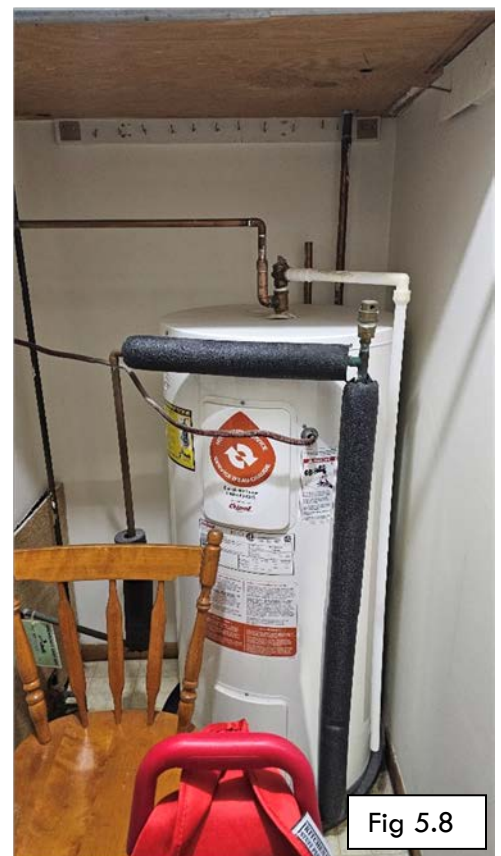
Fig 5.8

The domestic hot water is fed from individual 220V 40 Gal NB Power rental hot water heaters (See FIG 5.8) located in hallway closets in each unit.

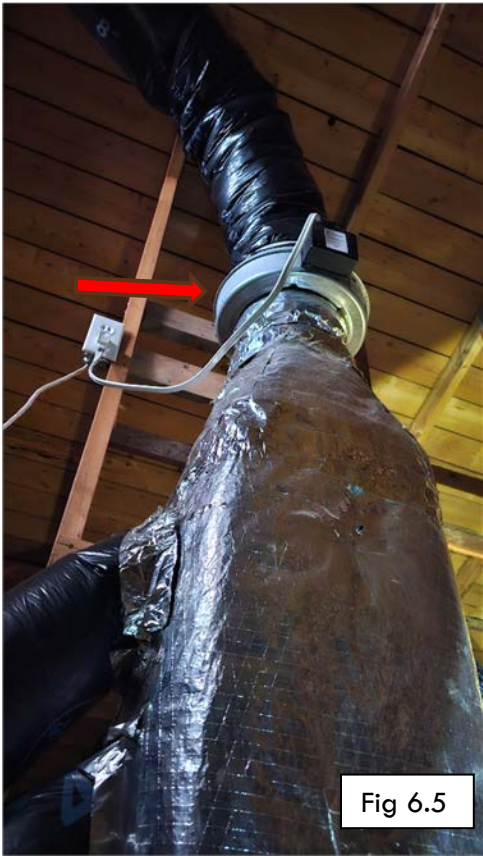
Fig 6.5

Units are required to contain exhaust to washrooms and kitchens and fresh supply to living rooms and bedrooms. This is typically provided by individual unit HRV's in modern construction. Minimum code allows for the use of exhaust fans and operable windows to provide fresh air and exhaust, each unit is equipped with a washroom exhaust (See Fig 6.6) and kitchen exhaust (See Fig 6.7) paired with operable windows. There is a central exhaust unit that connects to several exhaust lines with its own high-speed fan unit. This appears to be exhausting several connections (See Fig 6.4, 6.5).

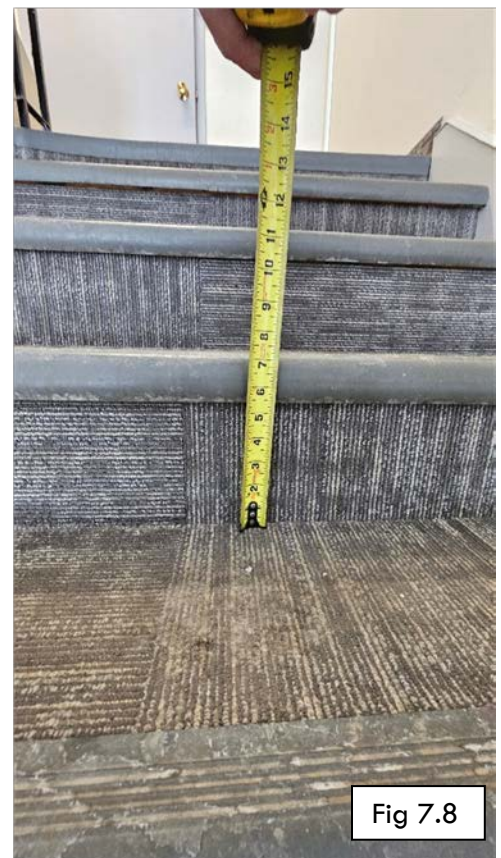
Fig 7.8

Stairs – Stairs are wood frame and are located on each end of the facility for exiting. The stairs do not conform to present day code requirements with excessive rise >7” and insufficient run (<11”) (See FIG 7.8, 7.9). Stairways are required to maintain a minimum headroom clearance of 2.08 m. Landing bulkheads restrict headroom to a non-conforming 1.93 m (See FIG 7.10). Stair railings are required to maintain continuous holding with wall clearances of 30 mm but railings are restricted to 12.7 mm at landing crossings (See FIG 7.11).

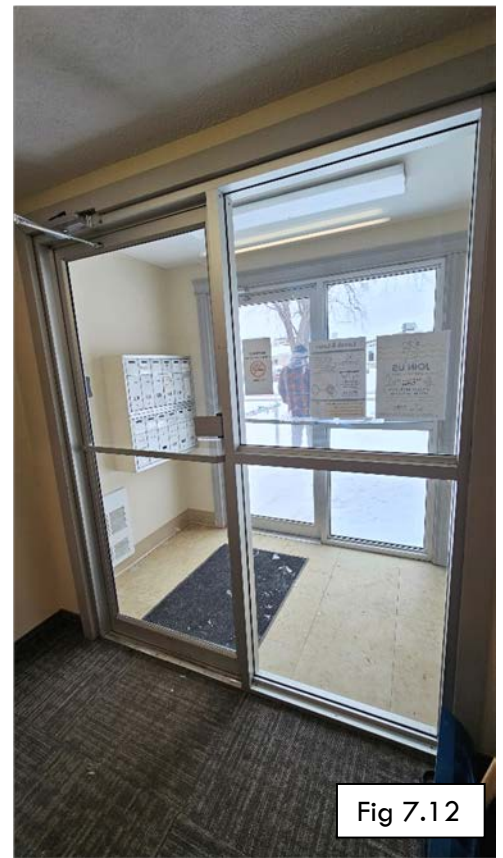
Fig 7.12

Doors – The main entrances are double aluminum commercial doors (See FIG 7.12). The entry doors are in good condition and operating as intended. Entrances are in conformance with the present use exiting requirements.

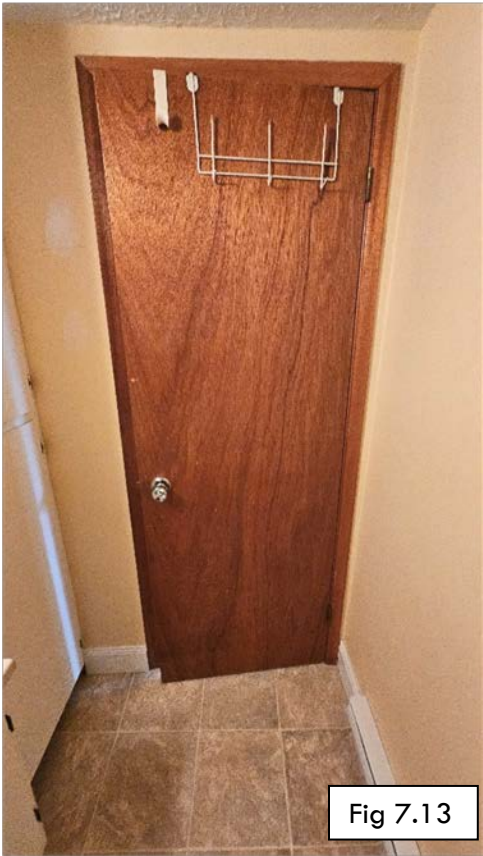
Fig 7.13

The interior doors are primarily wood veneer hollow core residential doors (See FIG 7.13) and remain functional but very dated in appearance. Door hardware appears to be original hardware of brass 1970’s styling. Unit entry doors are of poor sound quality and do not meet current fire rating requirements (See FIG 7.14). There were no UL ratings identified during inspections.
